# COMPLETED PROJECTS

# MEDAAN SERVICE REPORT ON MSC DIAMON 11 REFEER PROVISION STORE REPAIR.

ACTIVITY REPORT FOR MSC HAITI II REPAIRS IMO: 9225251

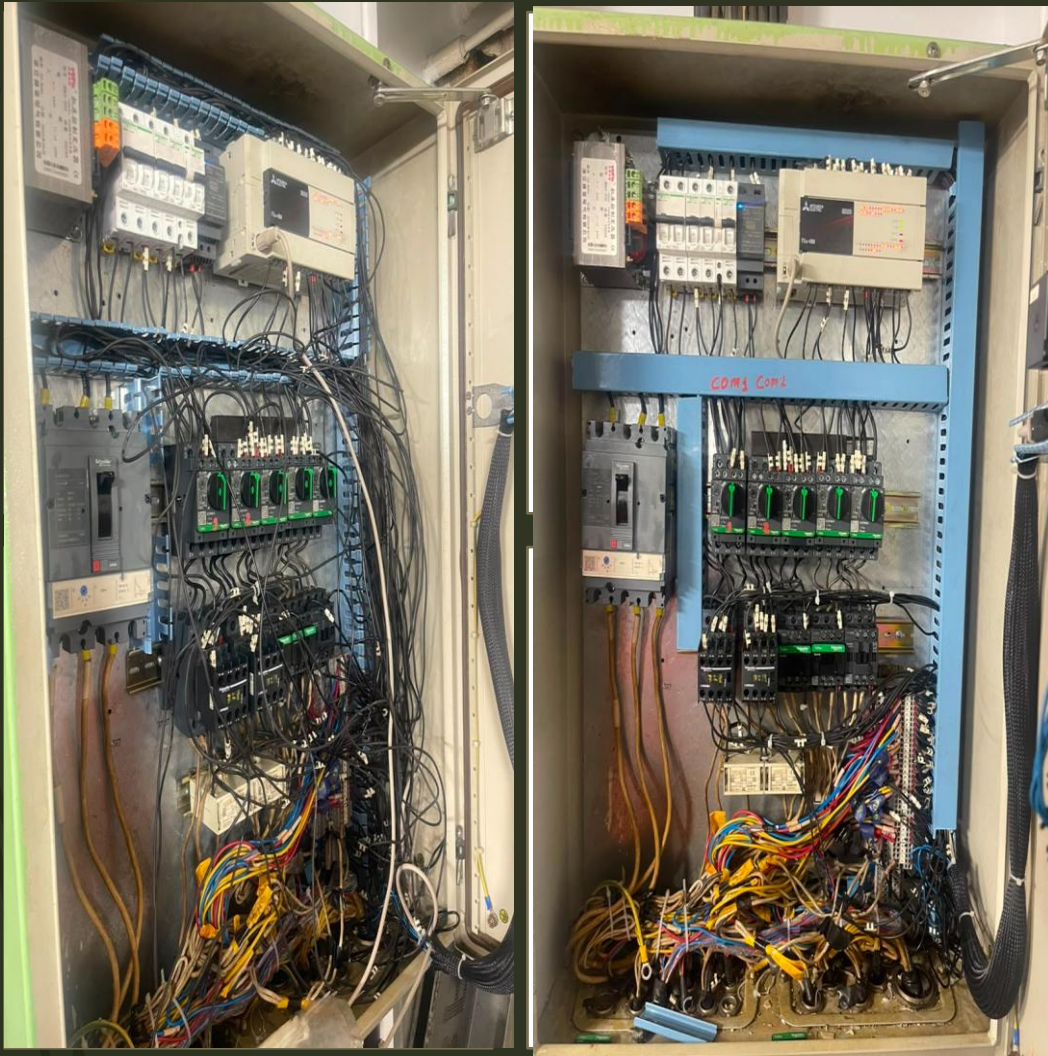
## Control panel

Control panel  
troubleshooting, repairs,  
and rewired.

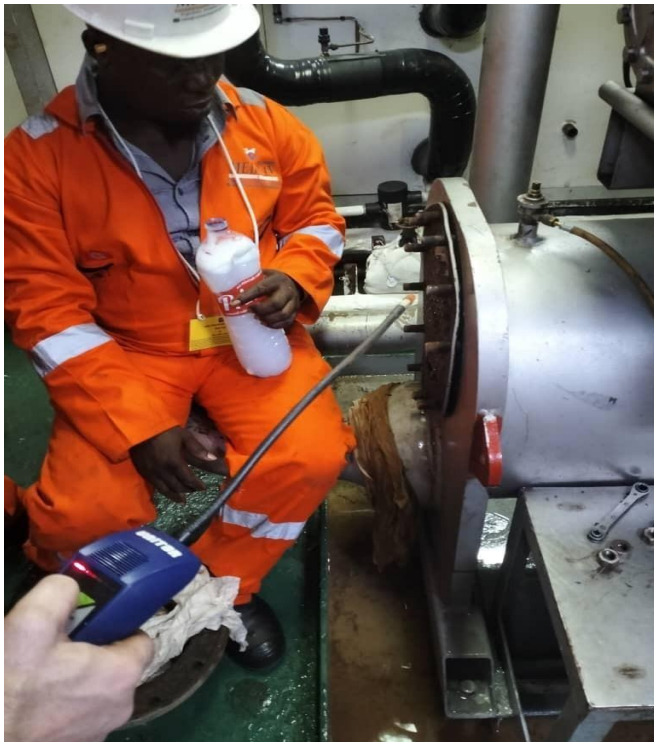
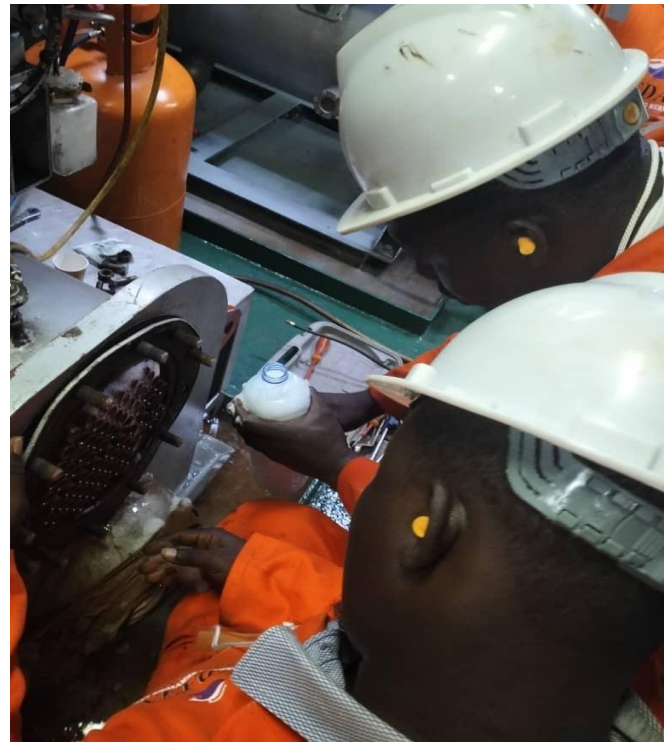
#### Medaam Team Testing Condenser Tubes For Leakages

1. The accommodation A.C plant 1 has leaks on pressure gauge lines.
2. Leakage on 3/8 pressure pipes, leakages on high pressure valves
3. Leakage and clogged condenser coils.
4. Defrosting Lines.
5. Low pressures alarm system
6. Refrigerant leakages

1. Fabrication of new pressure gauge lines using  $\frac{1}{4}$  size copper pipes.
2. Fixing of leakages on  $\frac{3}{8}$  pressure pipes.
3. Fixing of leakages on condenser tube by construction of brass bullets
4. Changing of gasket and seals around the condenser.
5. Flushing of the condenser using nitrogen gas
6. Replacement of compressor oil and compressor gas (407 gas).
7. We pressure test for Ten (10) hours with the pressure at 45psi and it maintains the pressure.

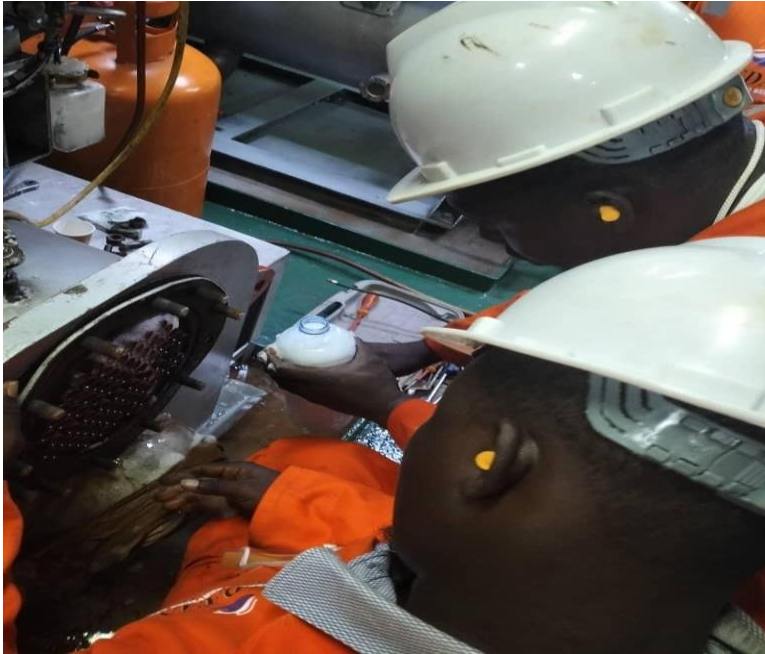
A.C condenser leakage findings

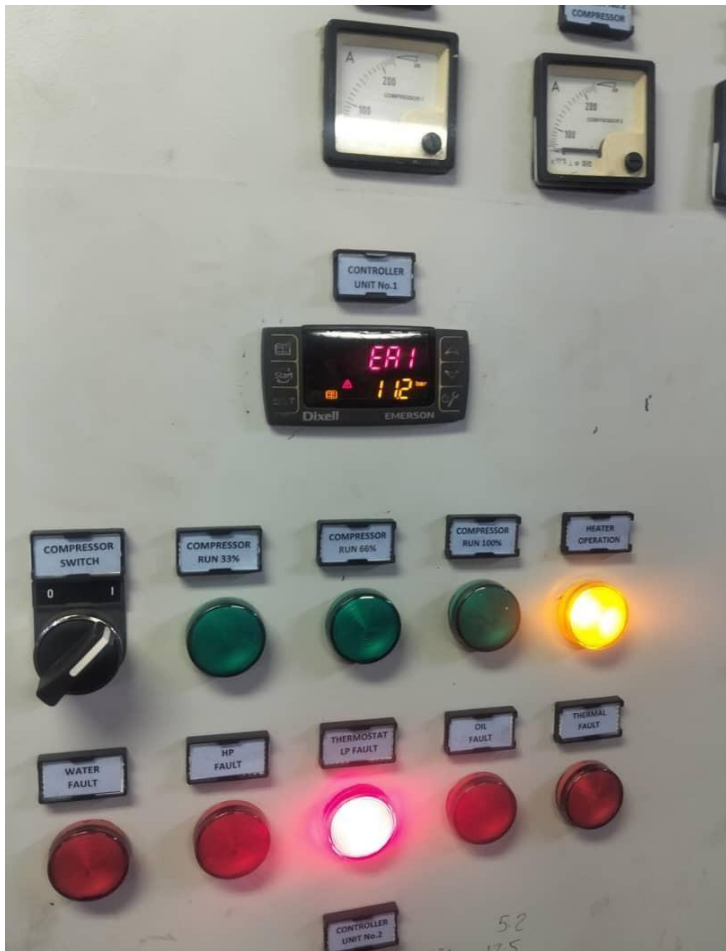
1. Faulty contactors
2. Faulty Electrical control wiring and connections
3. Faulty Electrical program panel
4. Faulty Temperature Sensors

Low Pressure Alarm System Before Repairs

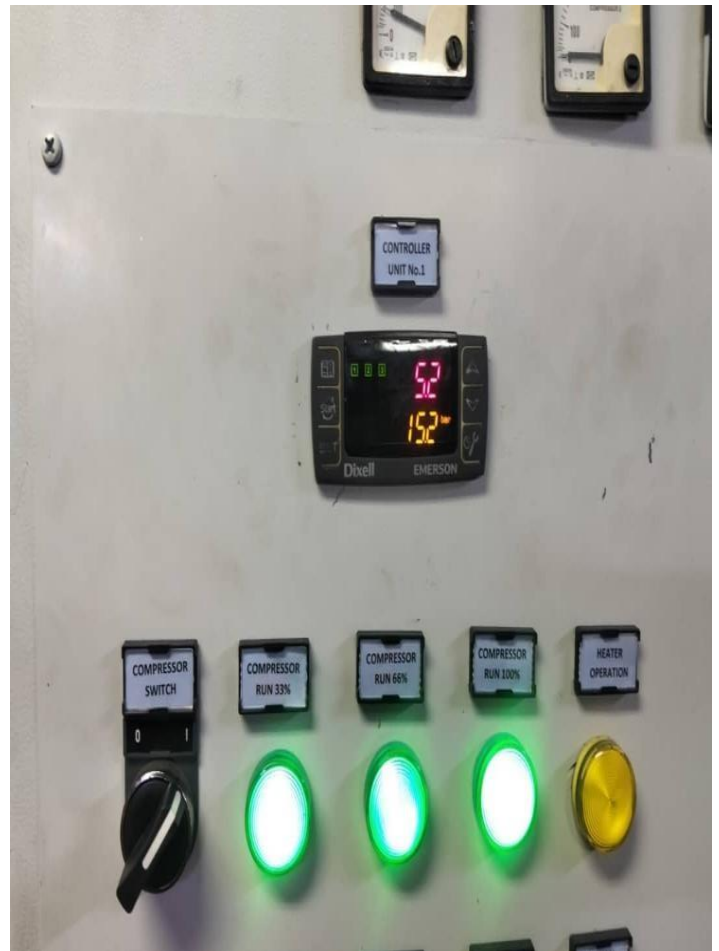
Low Pressure Alarm System After Repairs By Medaan Team

1. Repairs and serving faulty contactors
2. Electrical control wiring troubleshooting and terminals connections repairs and servicing
3. Repair Faulty Electrical program panel
4. Repairs Faulty Temperature Sensors

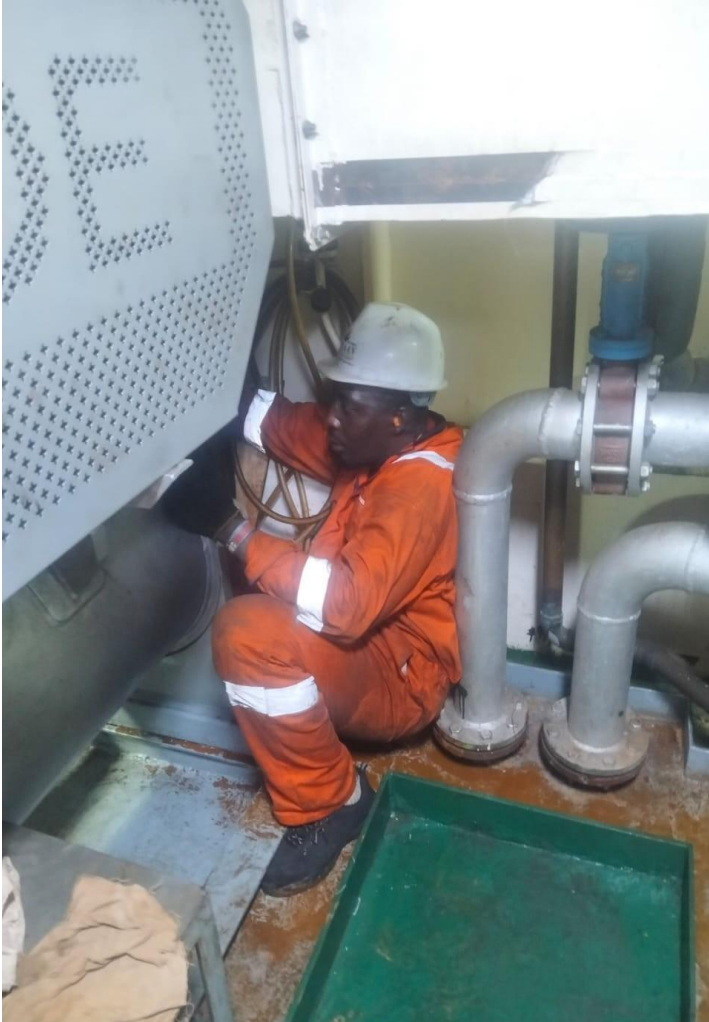
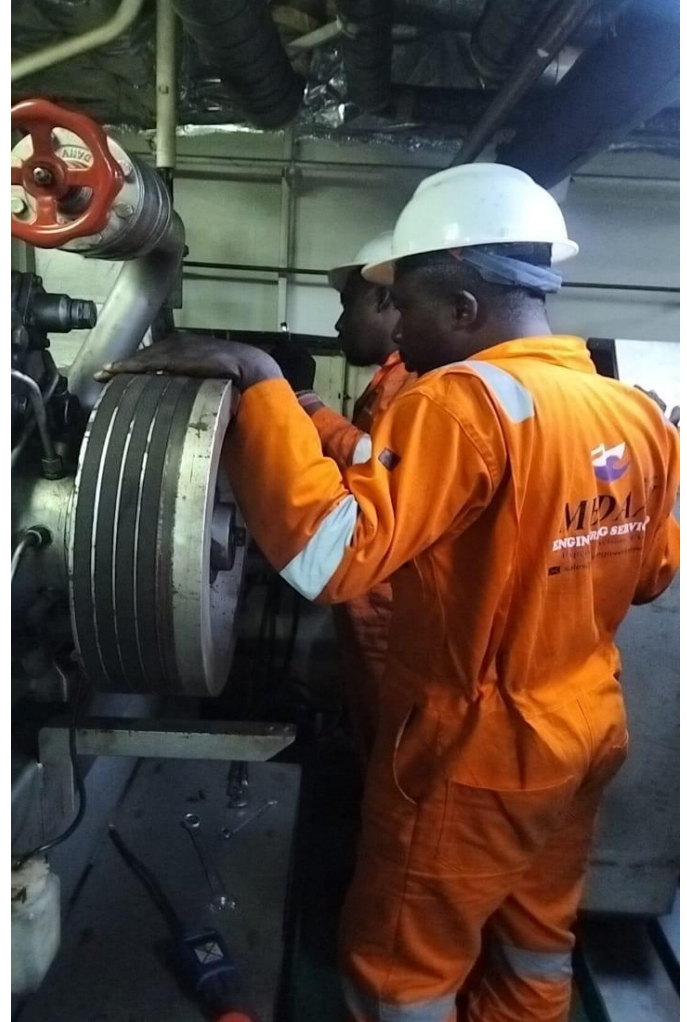
Reefer Refrigeration System On going Repair Work by Medaan Team

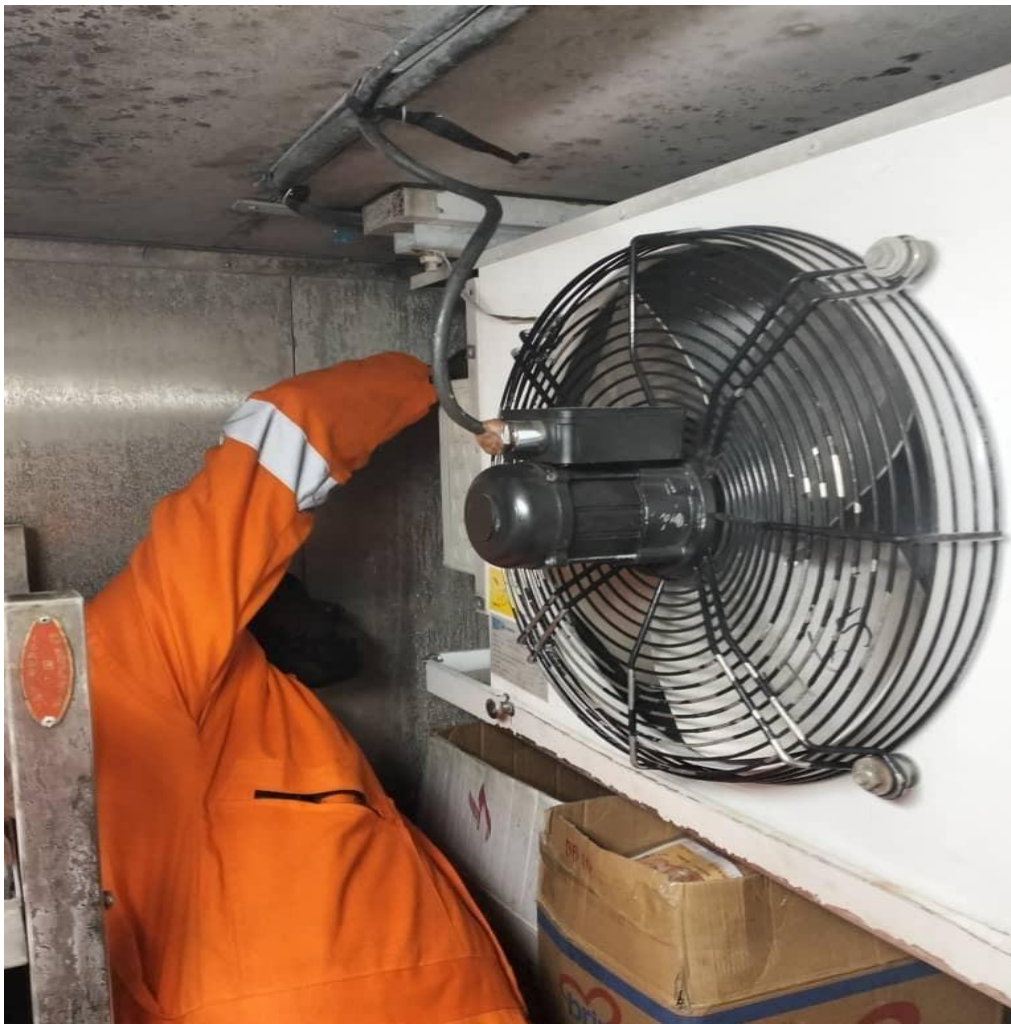
**Reefer Refrigerator Repairs by Medaan Team**  
**Medaan Team Tracing The De frozen Signal Cable To The Refrigeration Room.**
