# COMPLETED PROJECTS

# MEDAAN SERVICE REPORT ON MSC DIAMON 11 REFEER PROVISION STORE REPAIR.

ACTIVITY REPORT FOR MSC HAITI II REPAIRS IMO: 9225251

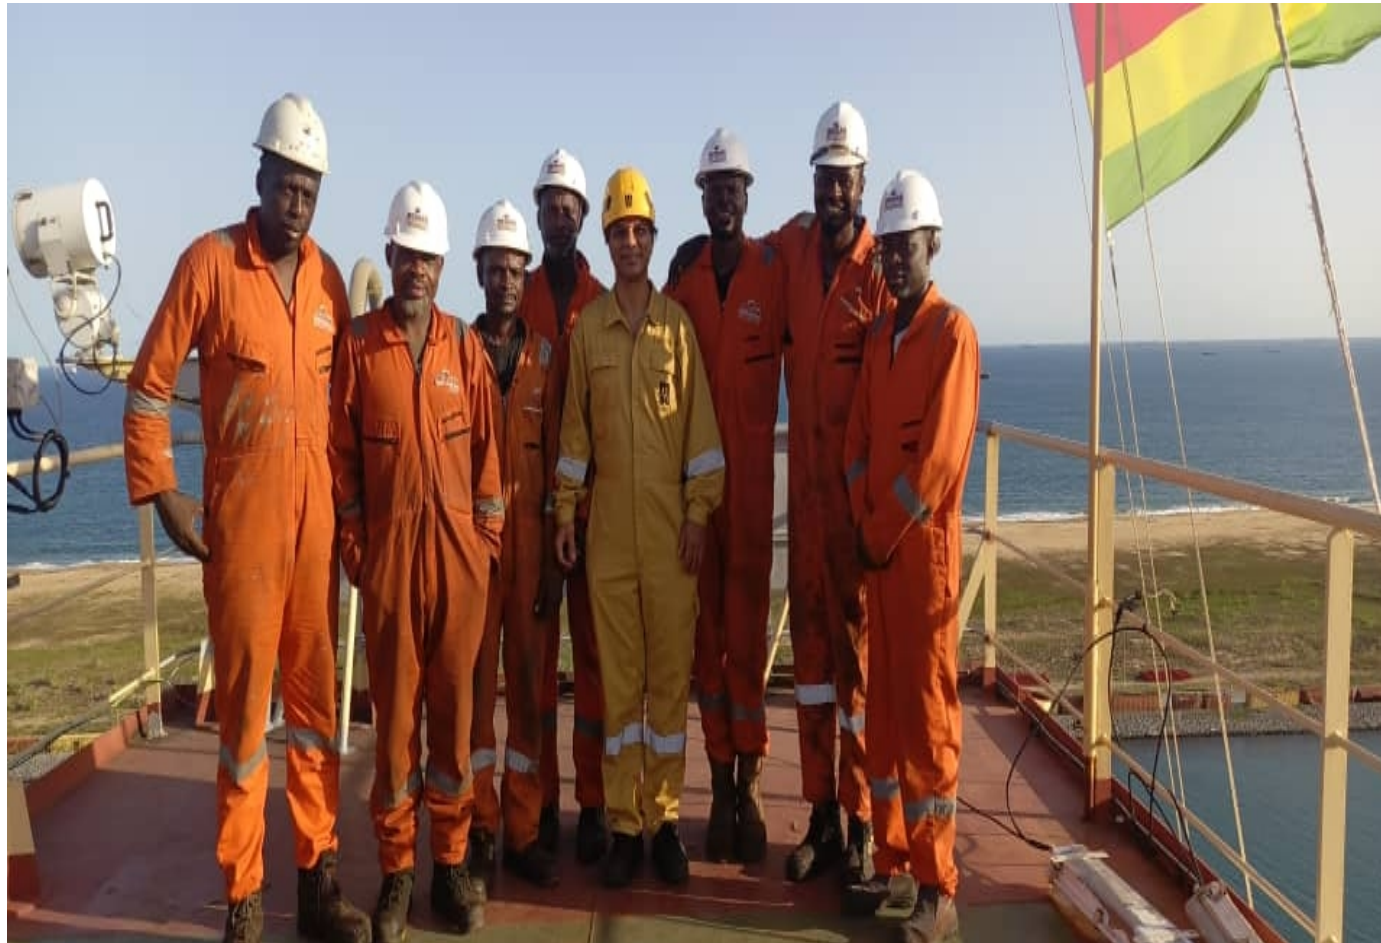
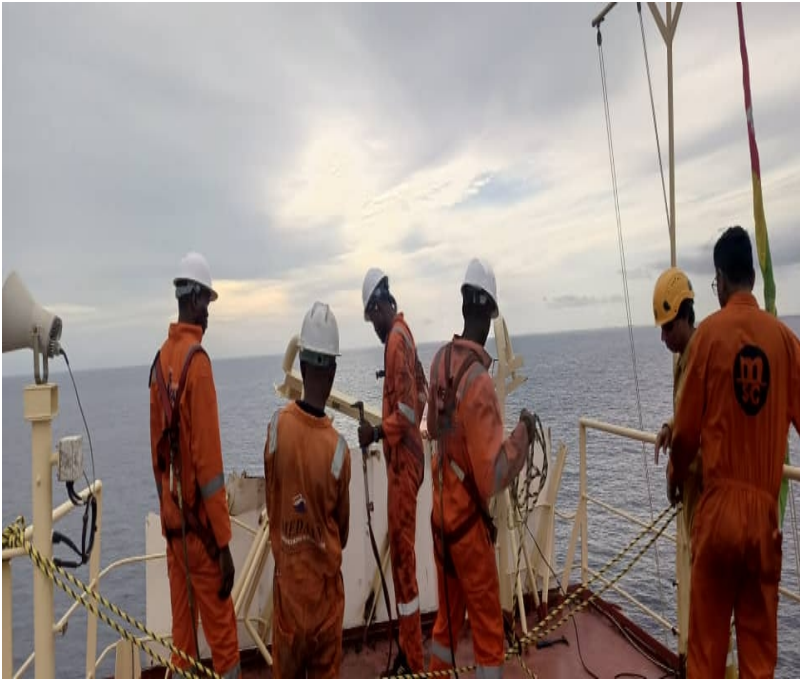
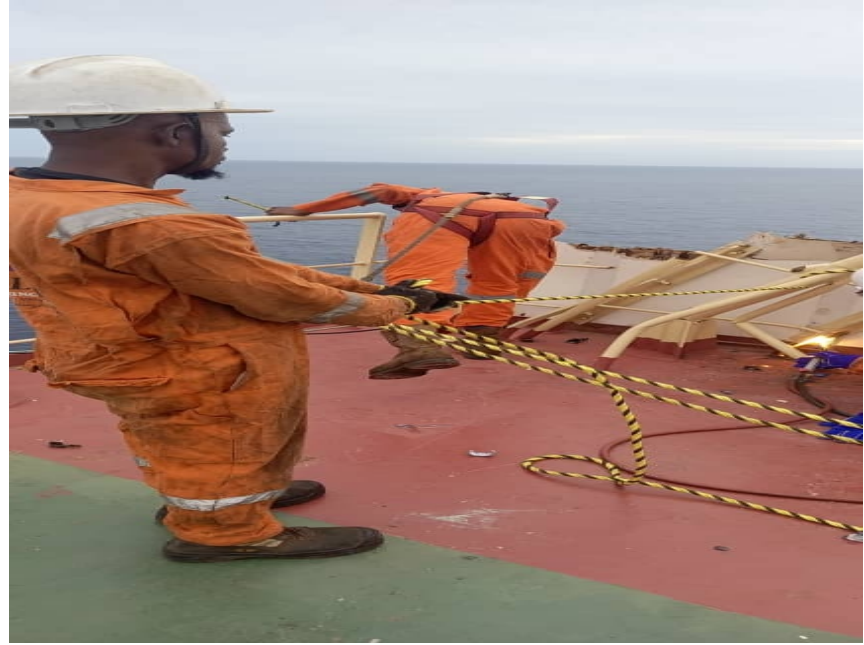
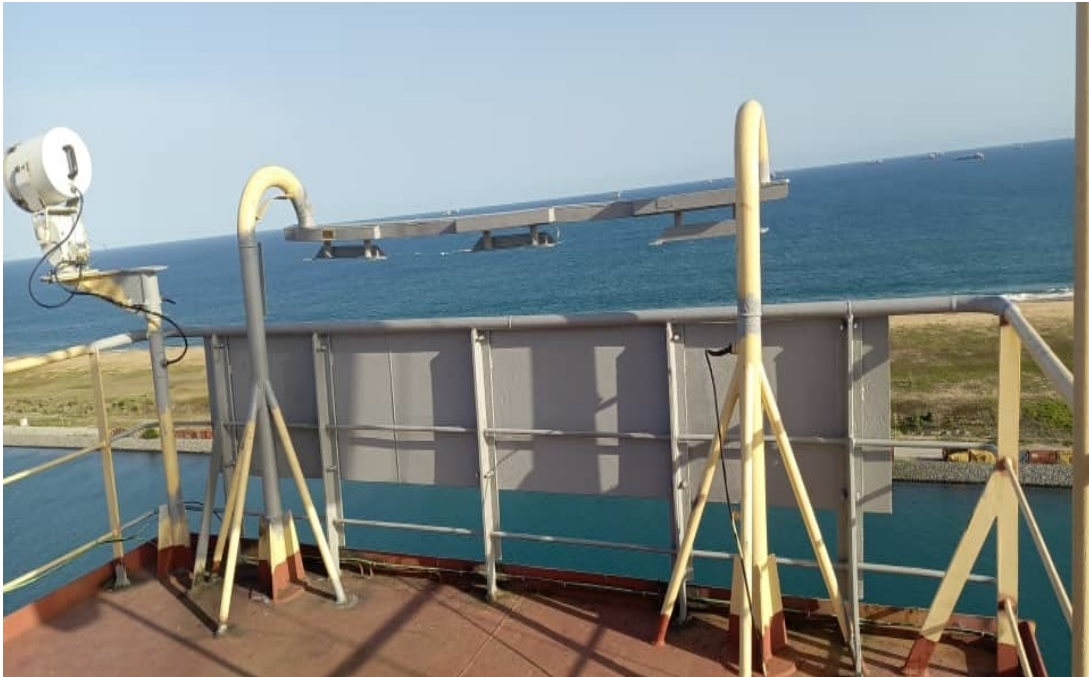
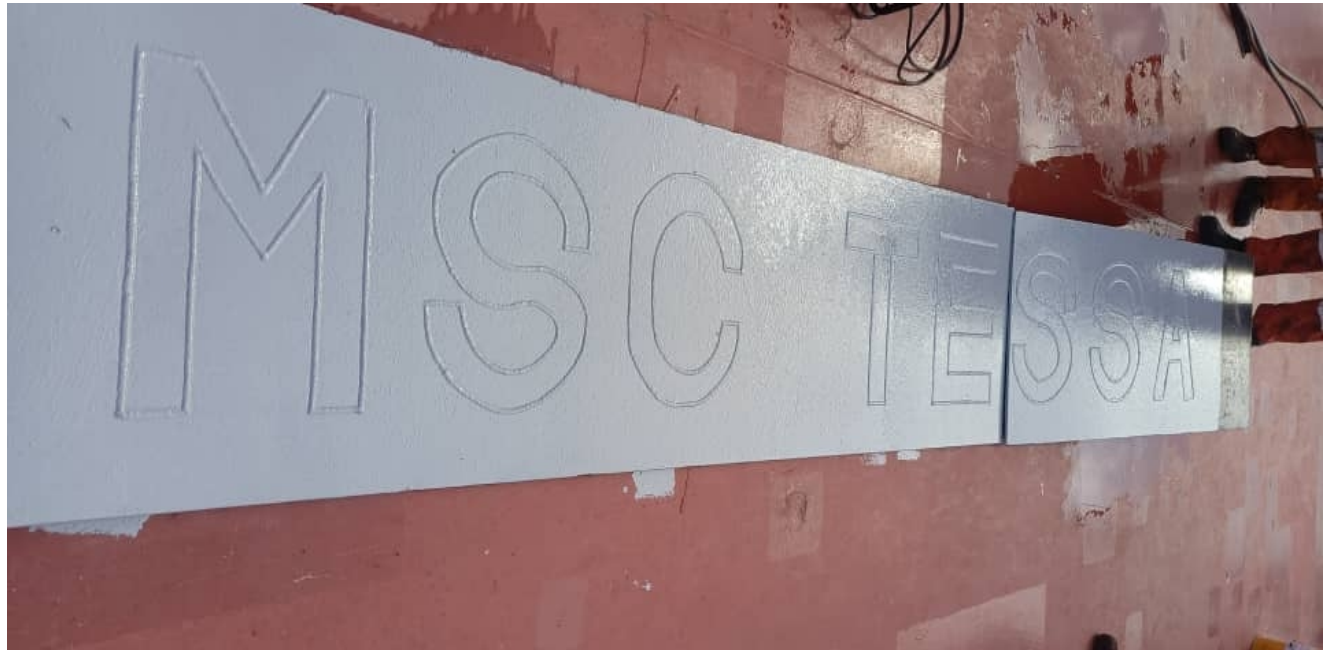
**Project Title: BRIDGE WING REPAIRS**

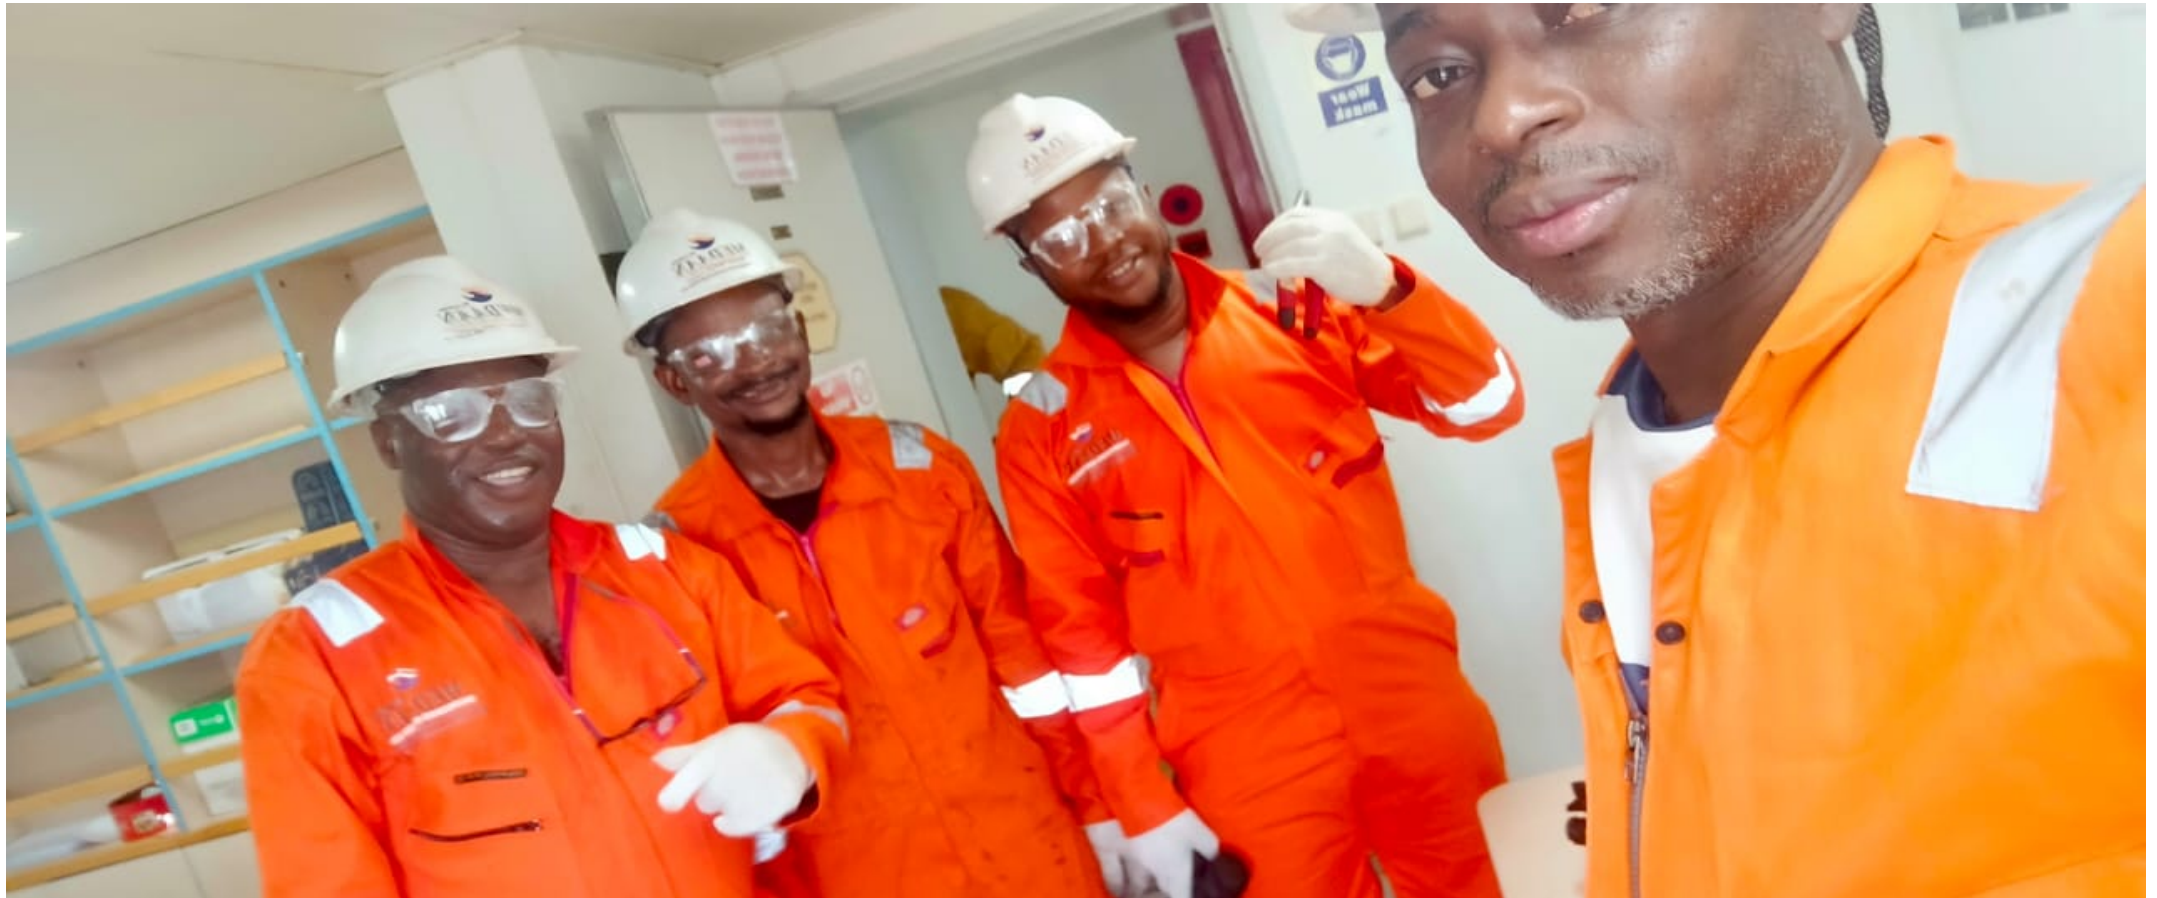
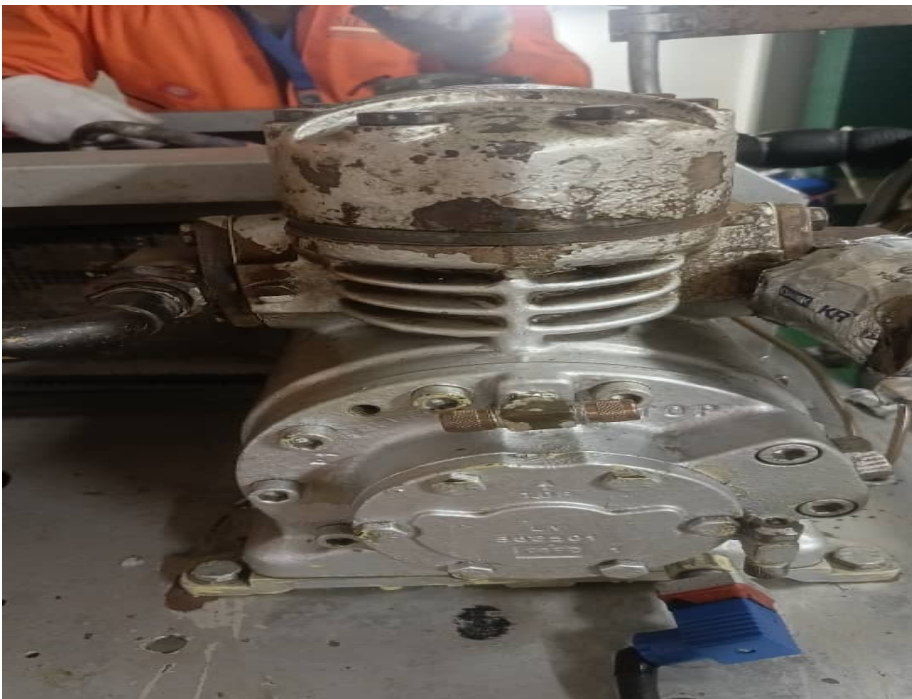
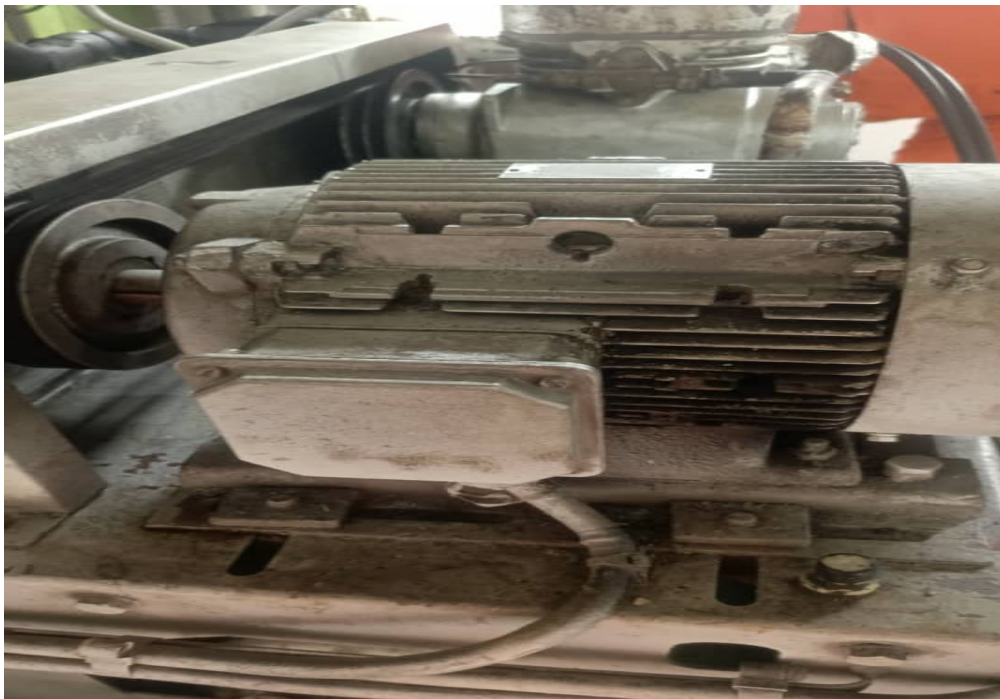
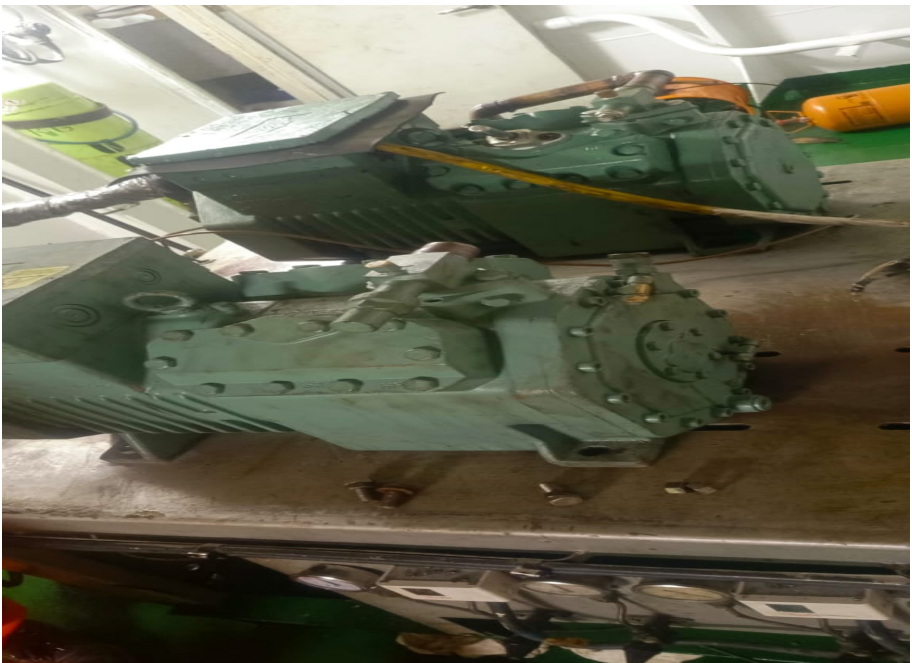
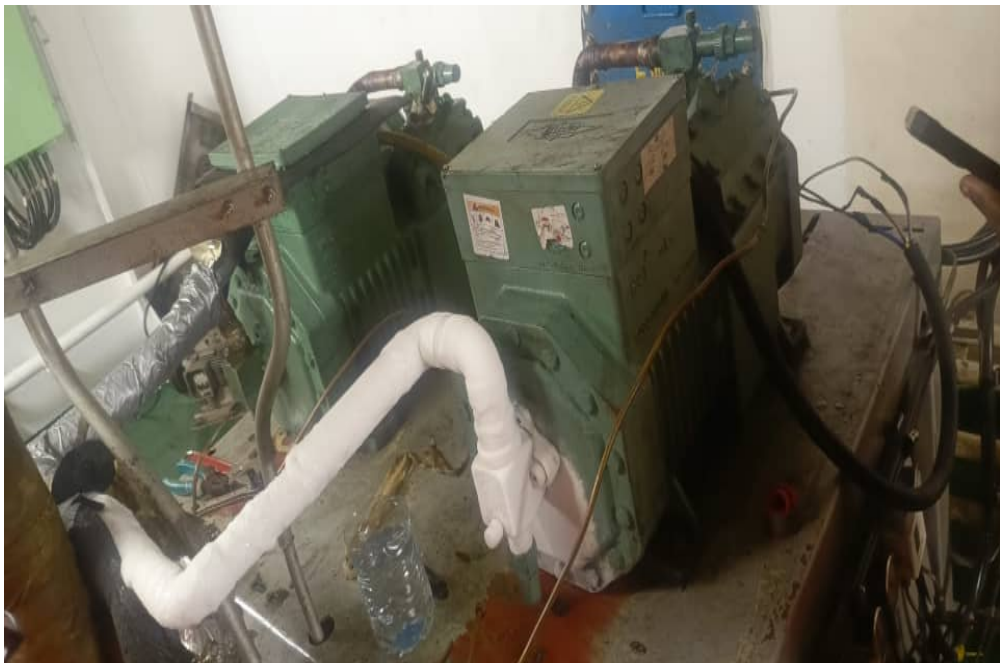
**Project Title: REFEER PROVISION STORE COMPRESSORS  
REPLACEMENT**

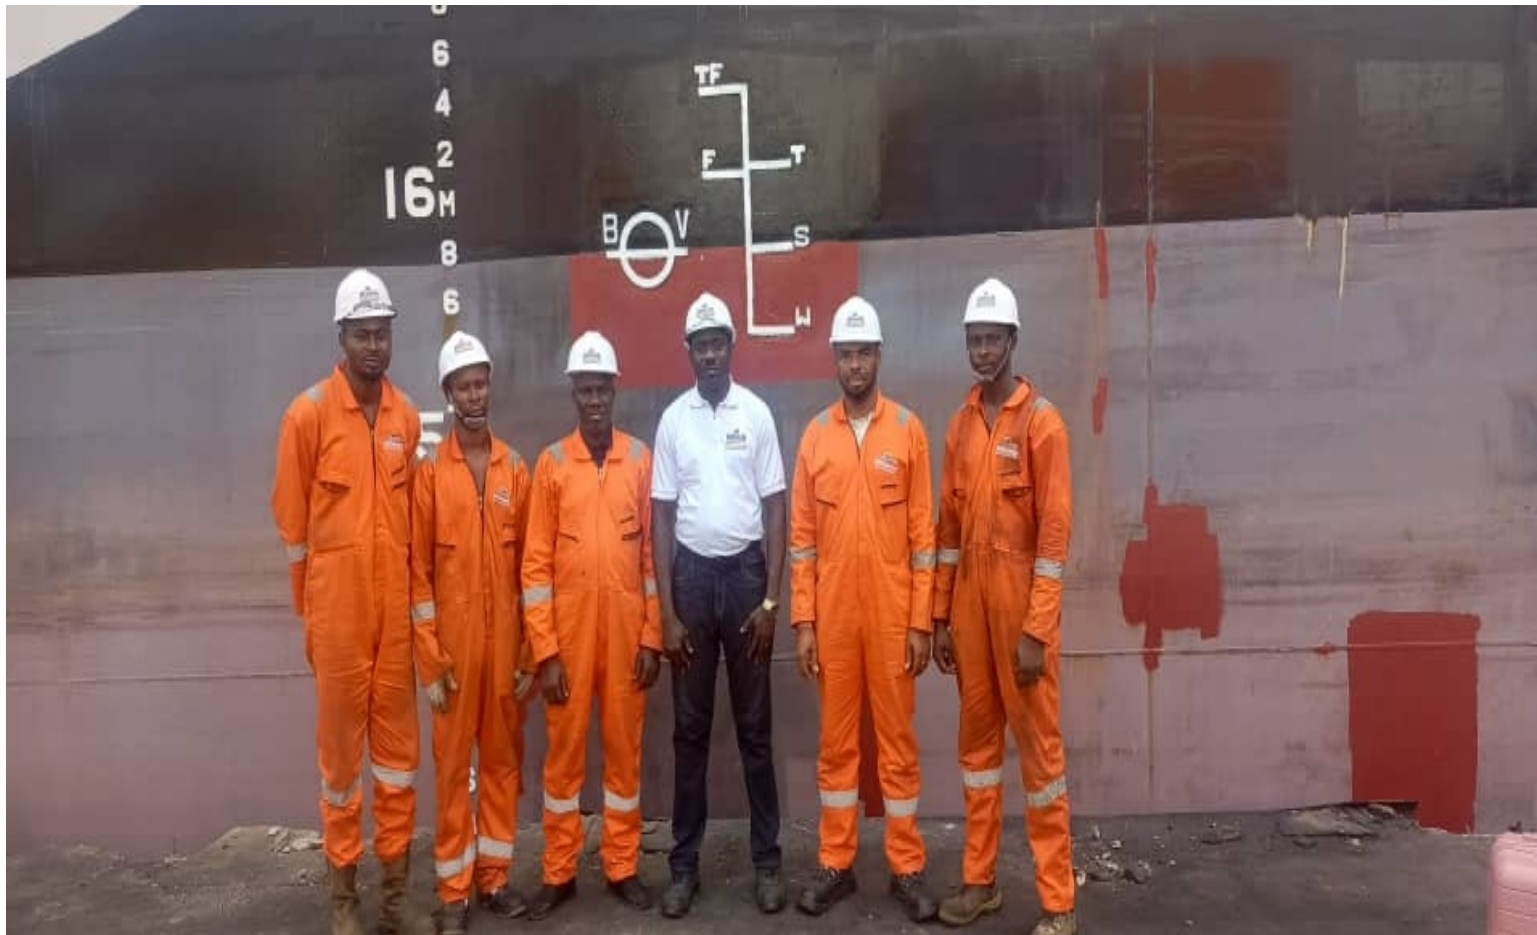
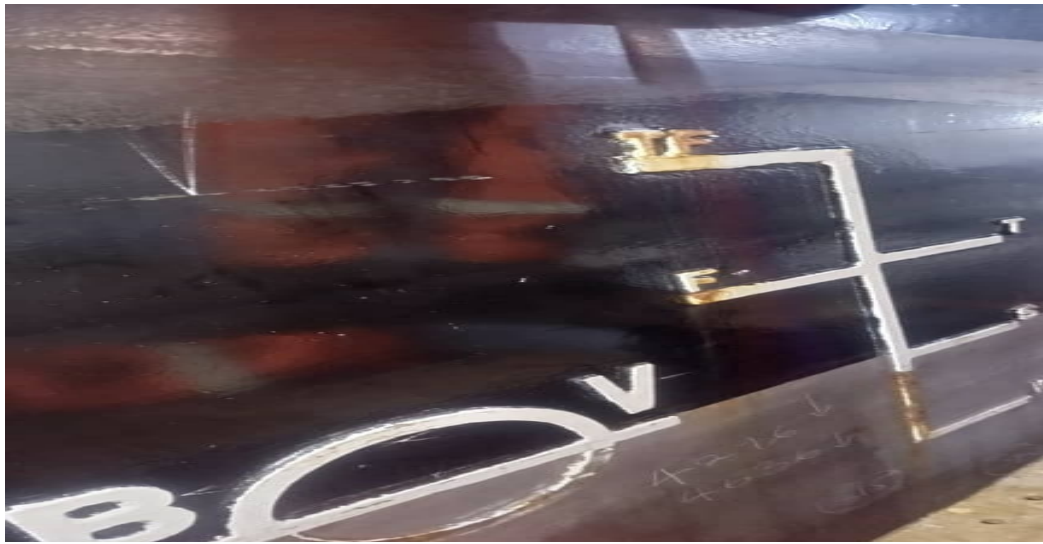
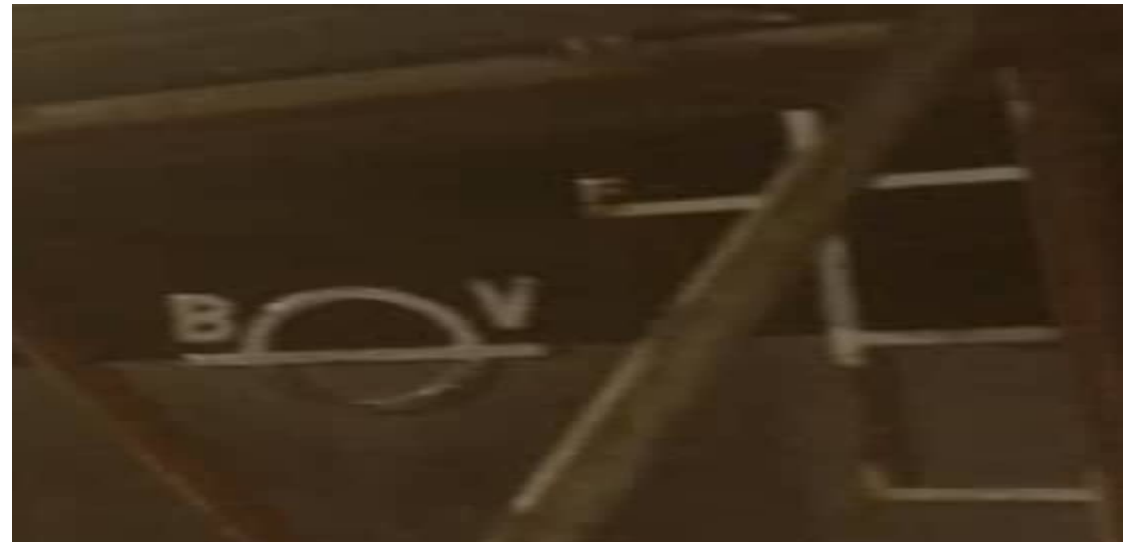
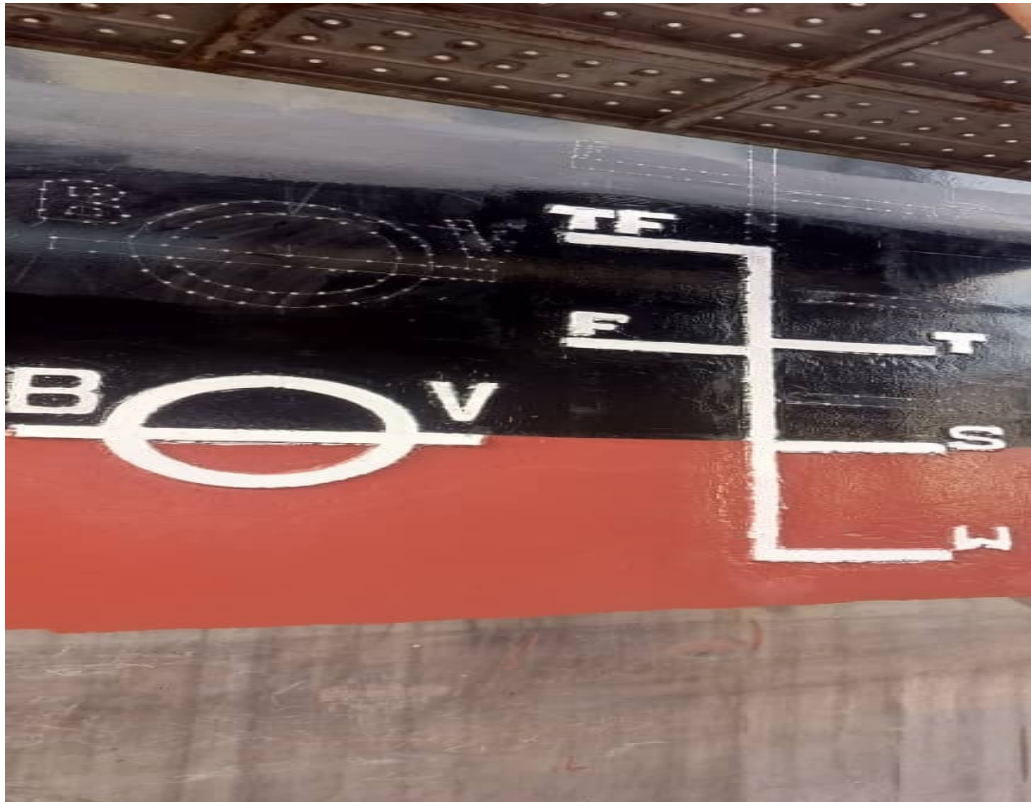
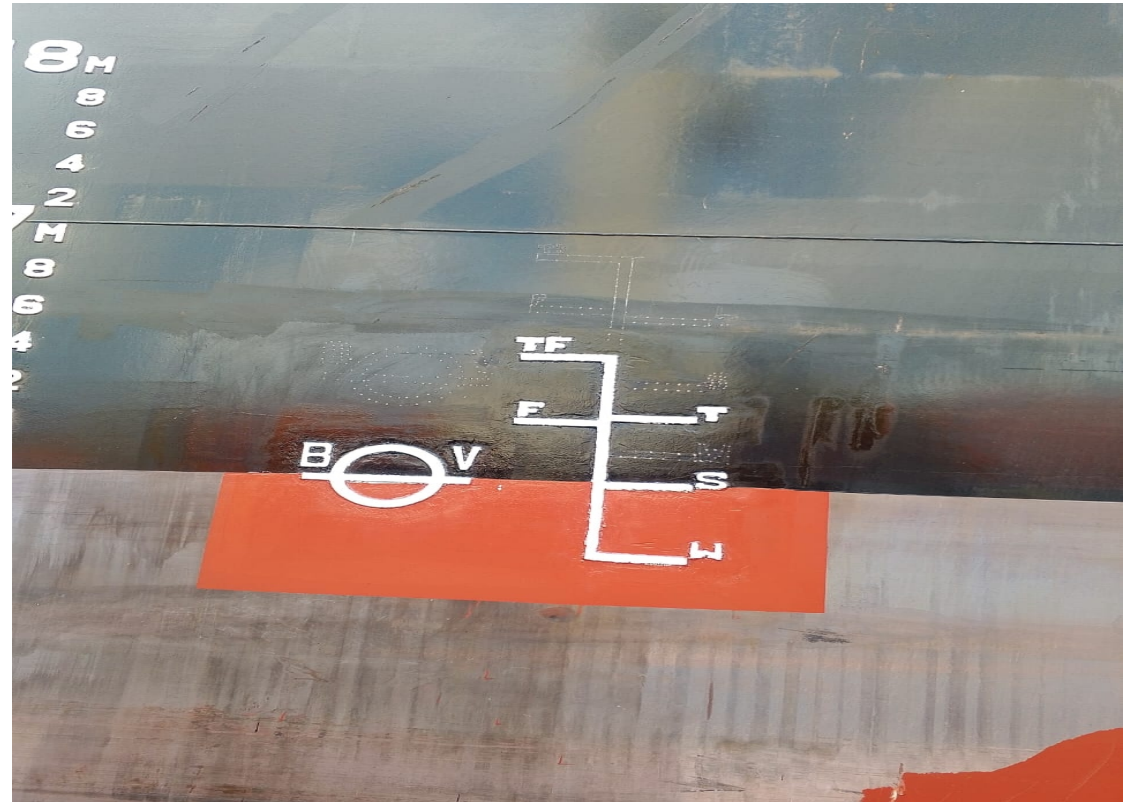
**Project Title: LOAD LINE MARKING**

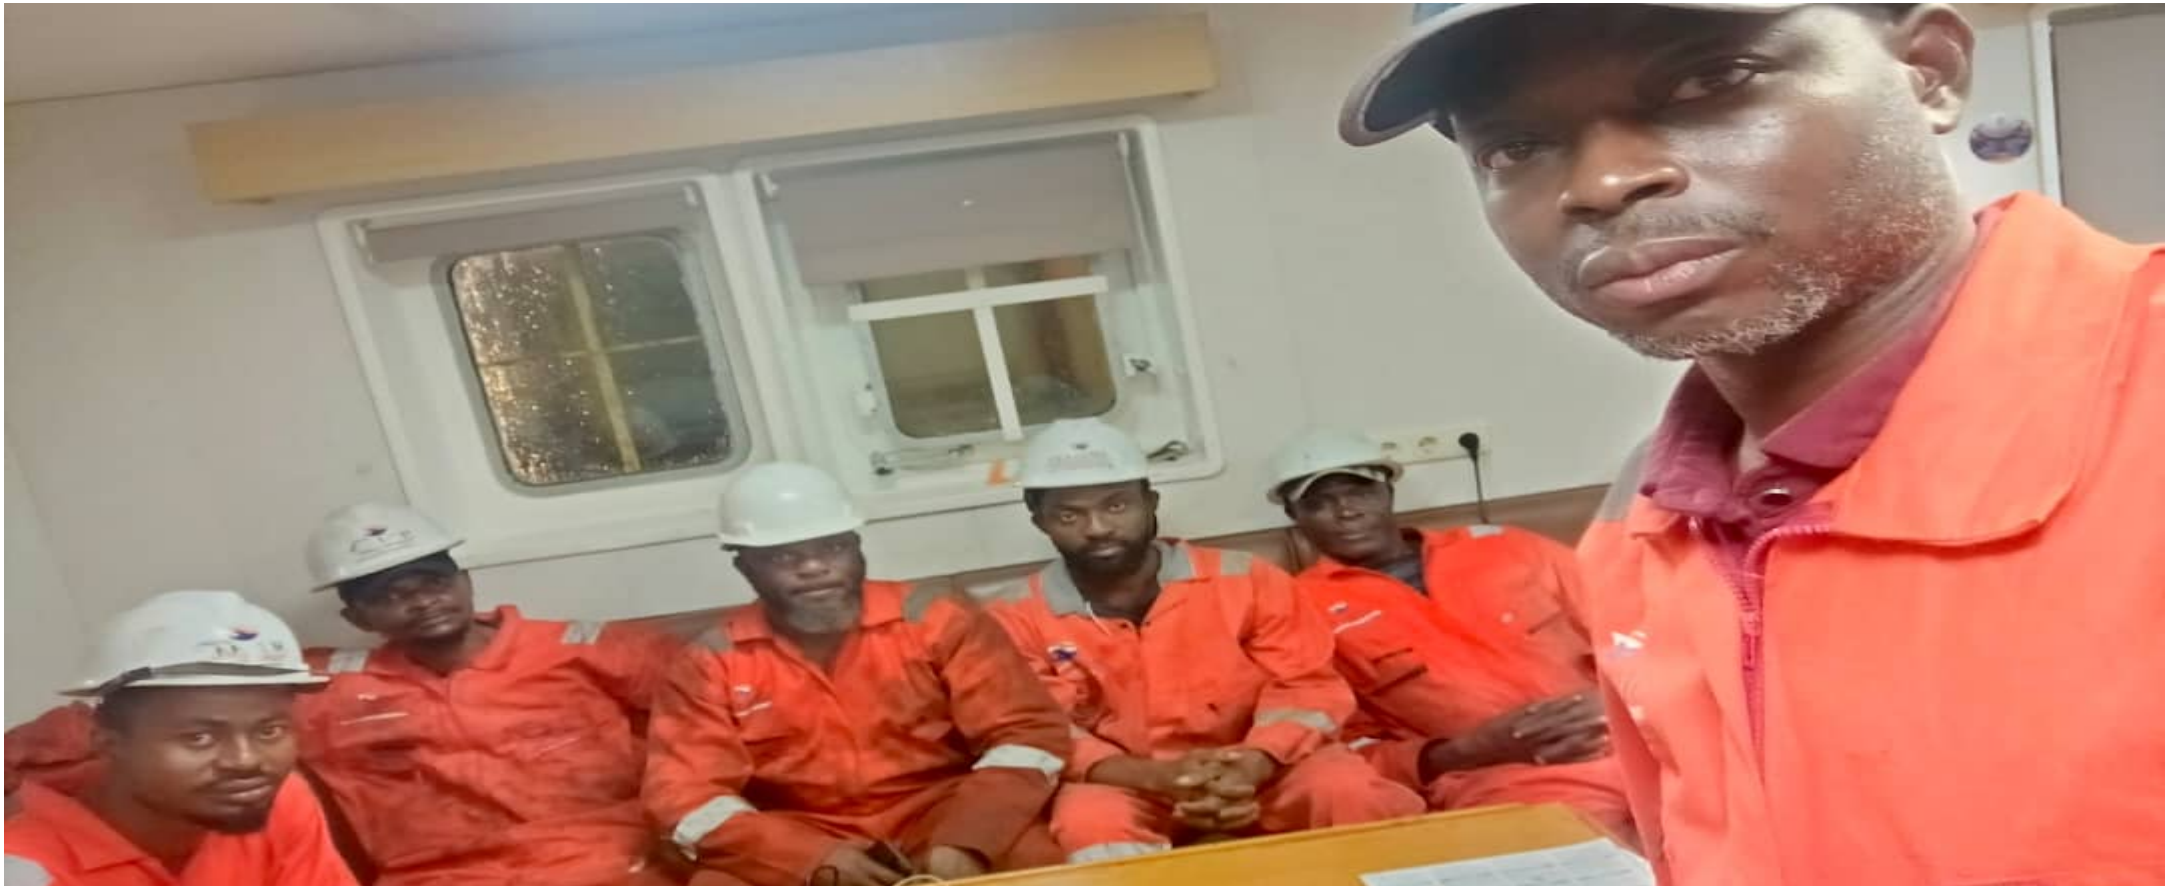
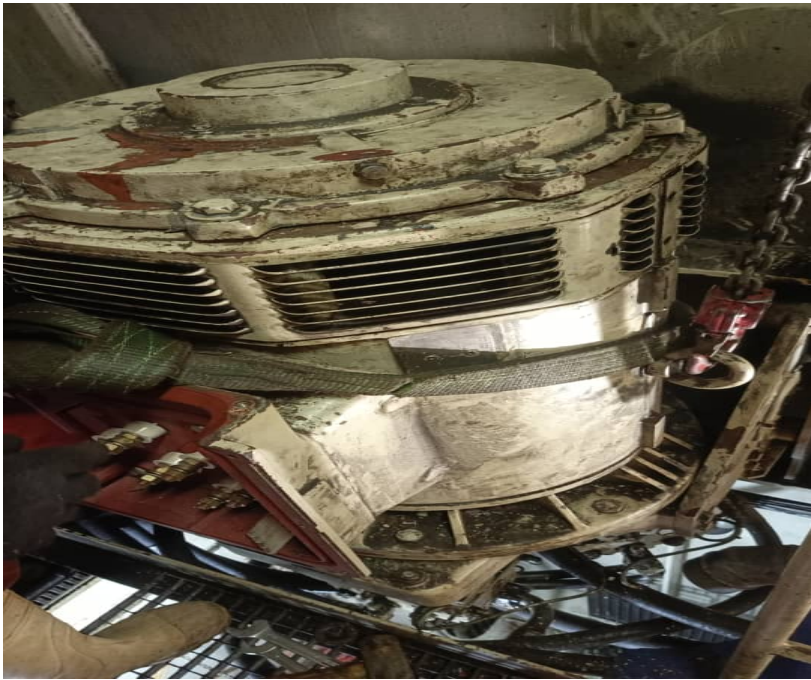
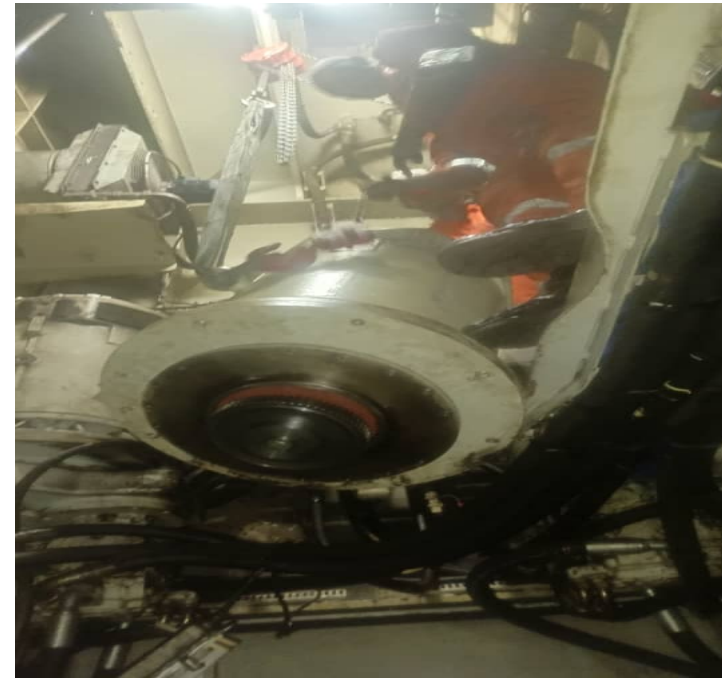
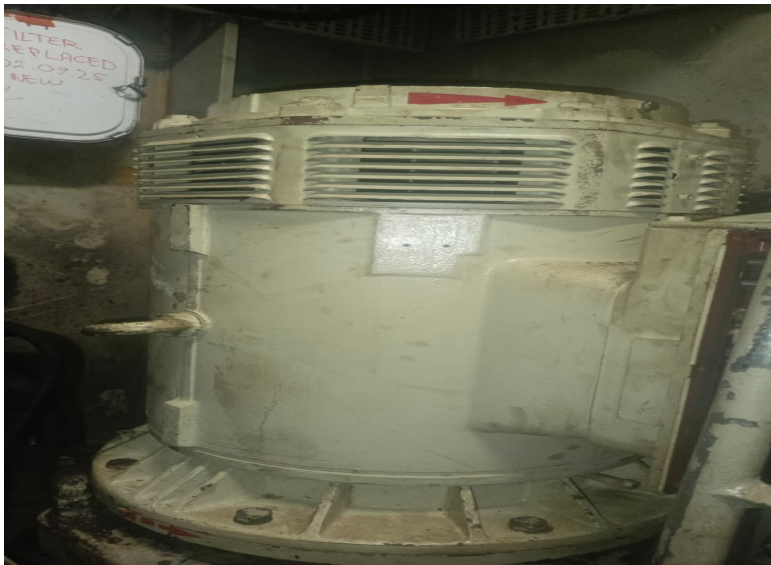
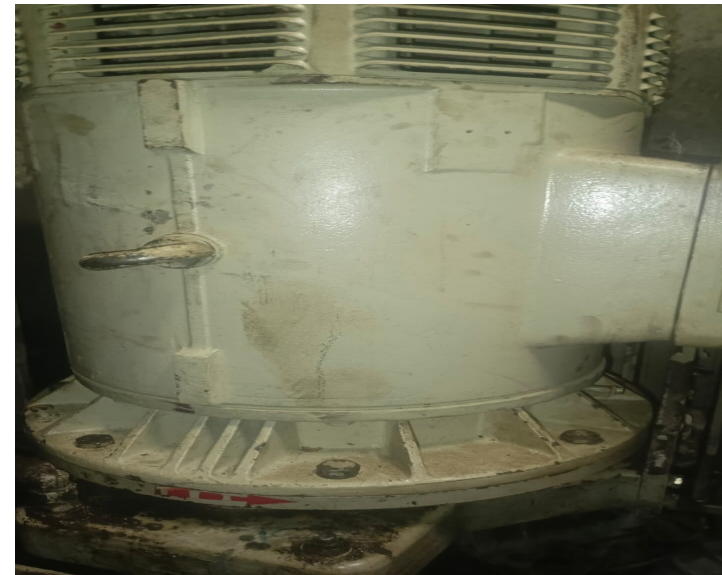
**Project Title: DECK CRANE HYRAULIC PUPMP MOTOR  
REPLACEMEN**

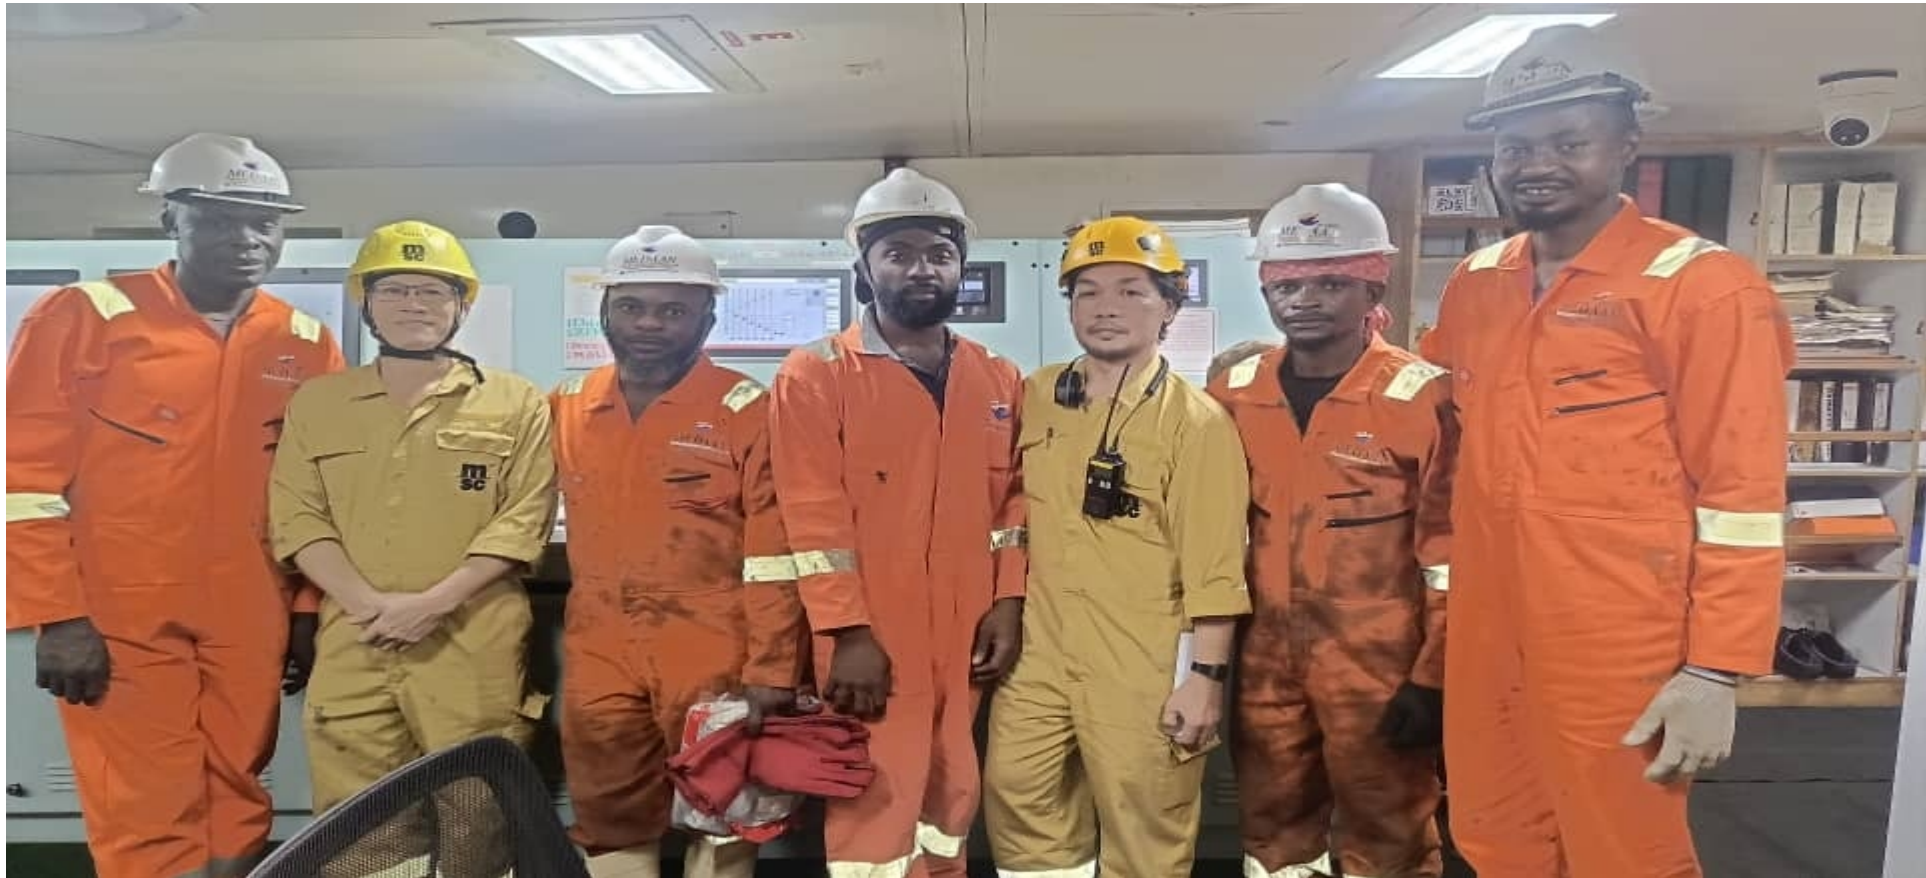
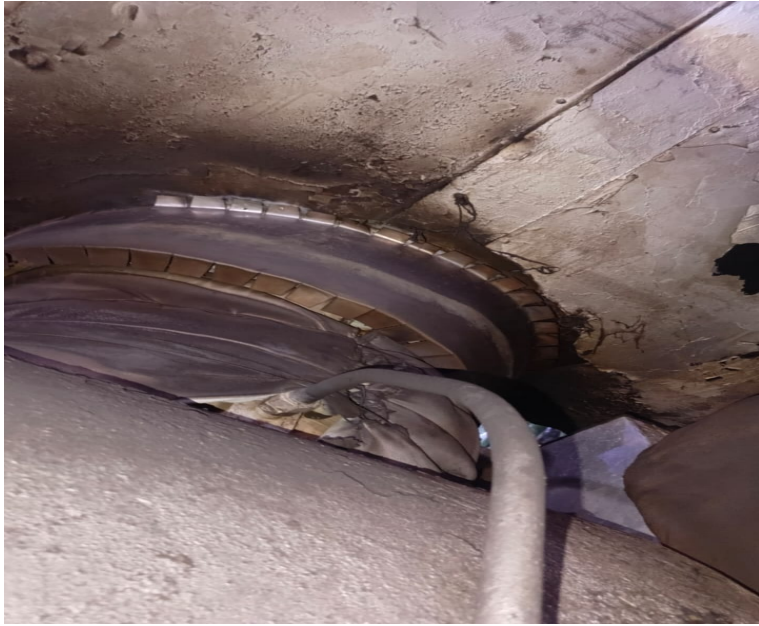
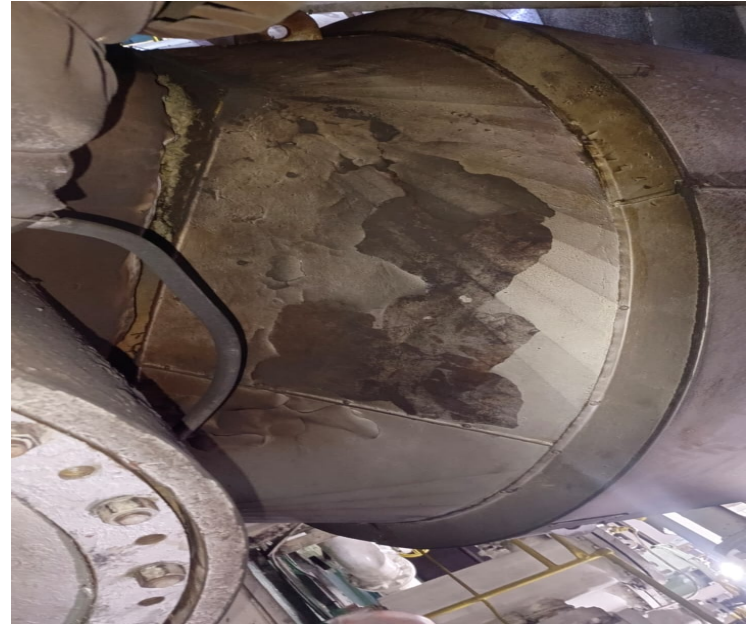
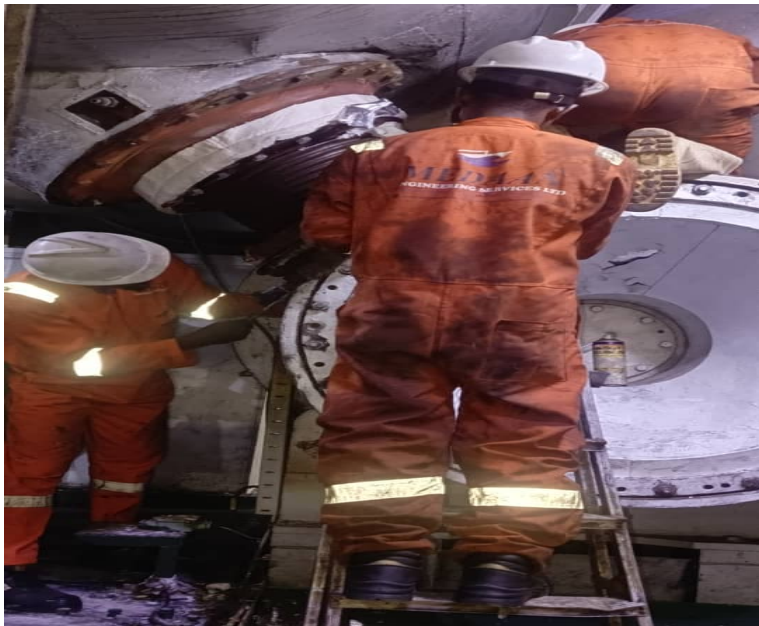
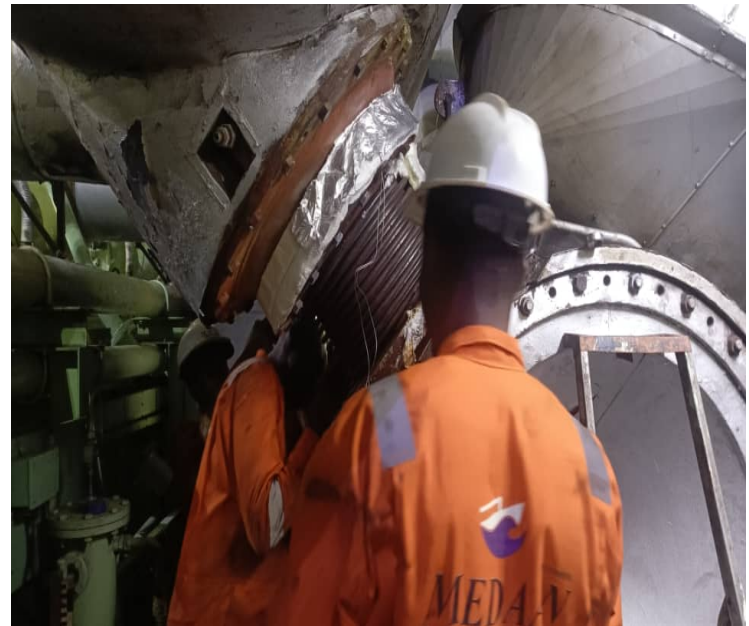
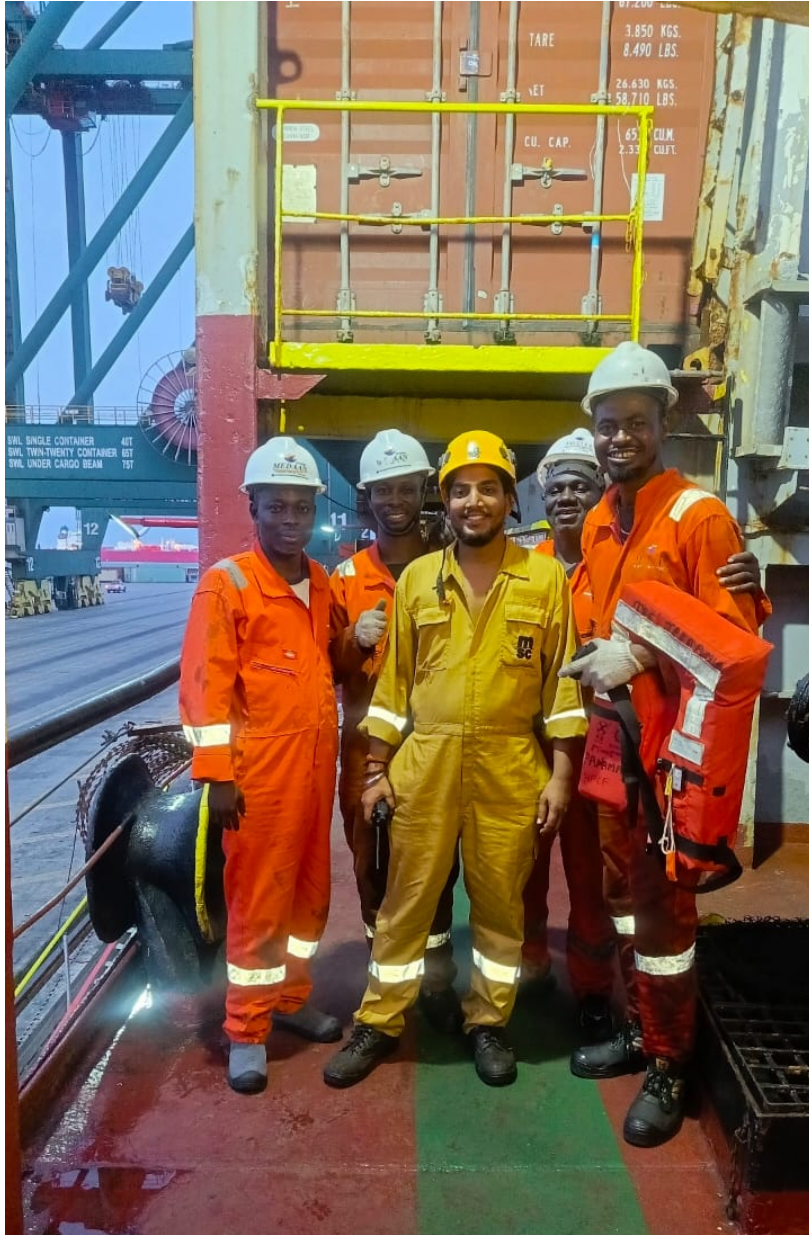
**Project Title: MAIN ENGINE EXHAUST SYSTEM LEAKAGE  
REPAIRS**
