# COMPLETED PROJECTS

# MEDAAN SERVICE REPORT ON MSC DIAMON 11 REFEER PROVISION STORE REPAIR.

ACTIVITY REPORT FOR MSC HAITI II REPAIRS IMO: 9225251

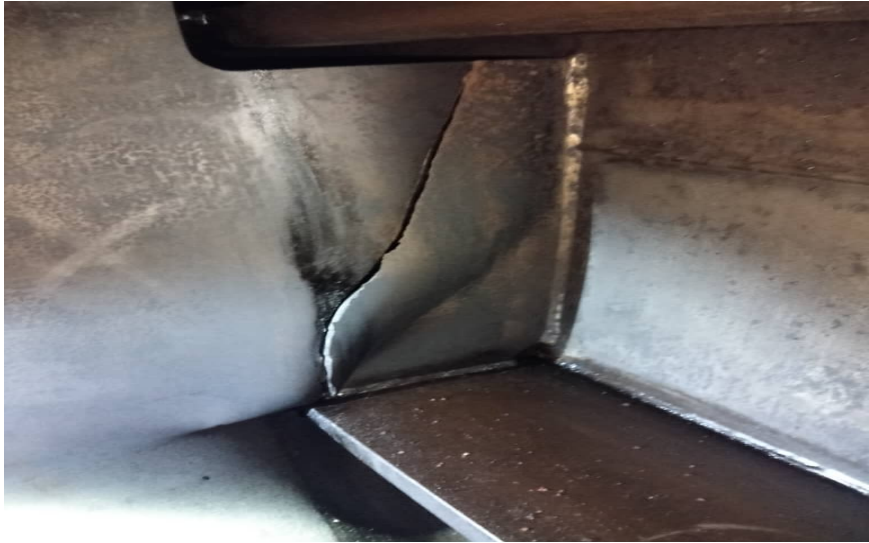
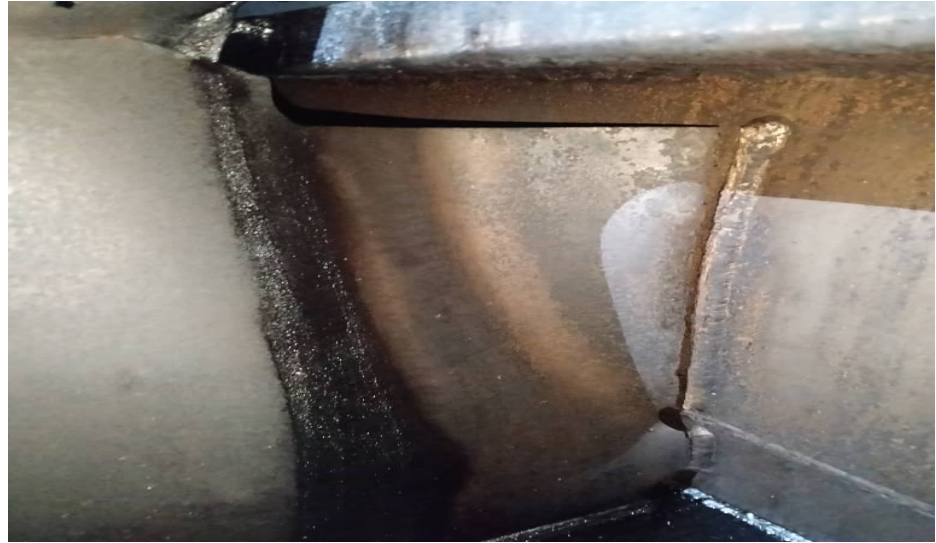
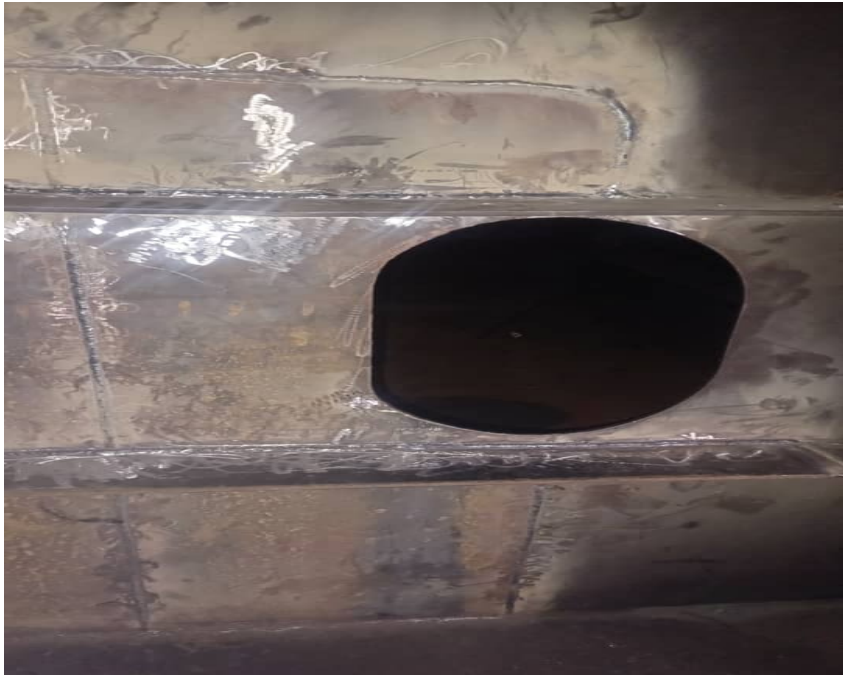
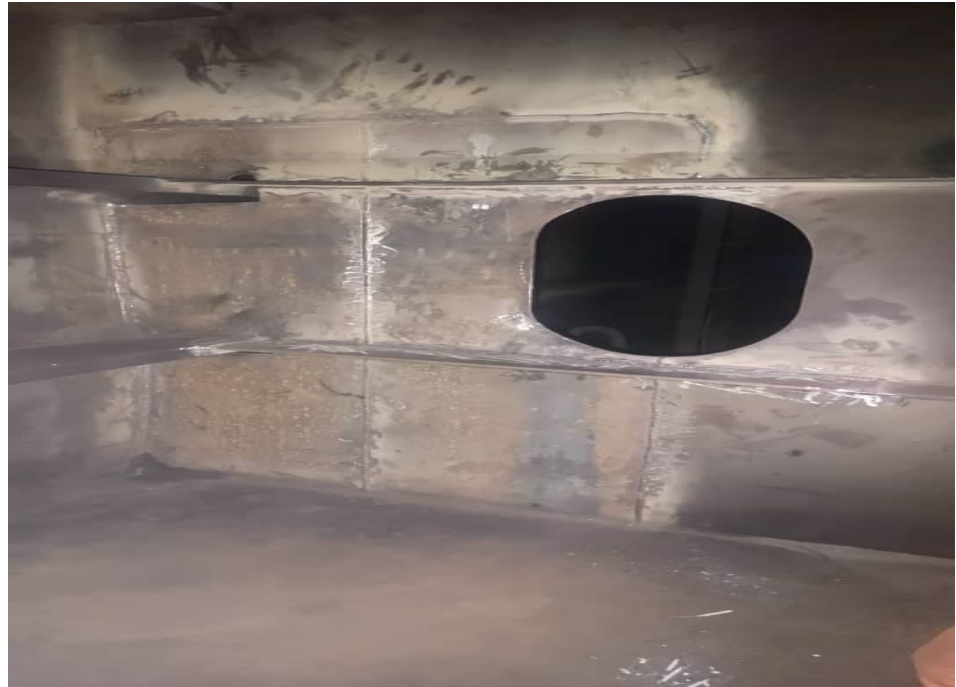
**Project Title: BUNKER TANK REPAIR**  
**Project Location; SAN PEDRO /ABIDJAN**  
**Date Completed: 10<sup>TH</sup> JUNE,2025**  
**Customer Name: CONTAINER CARGO VESSEL**

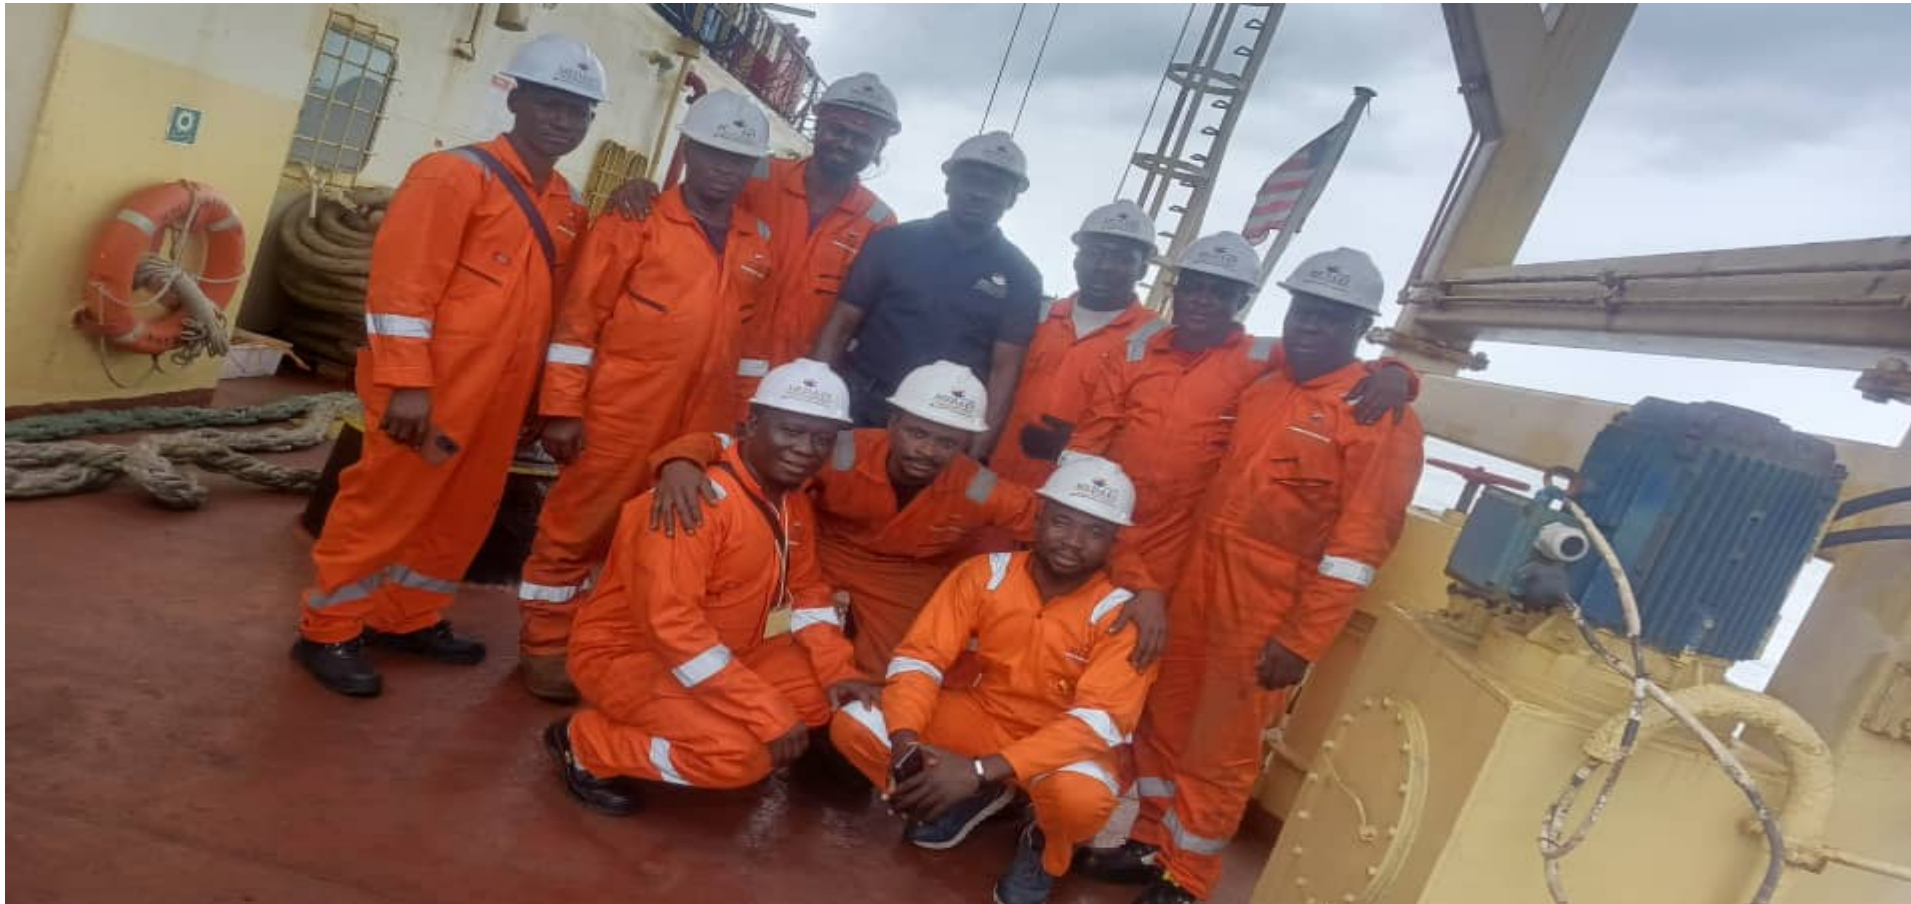
**Project Title: SEA WATER PIPES REPAIRS**  
**Project Location; SAN PEDRO /ABIDJAN**  
**Date Completed: 10<sup>TH</sup> JUNE,2025**  
**Customer Name: CONTAINER CARGO VESSEL**

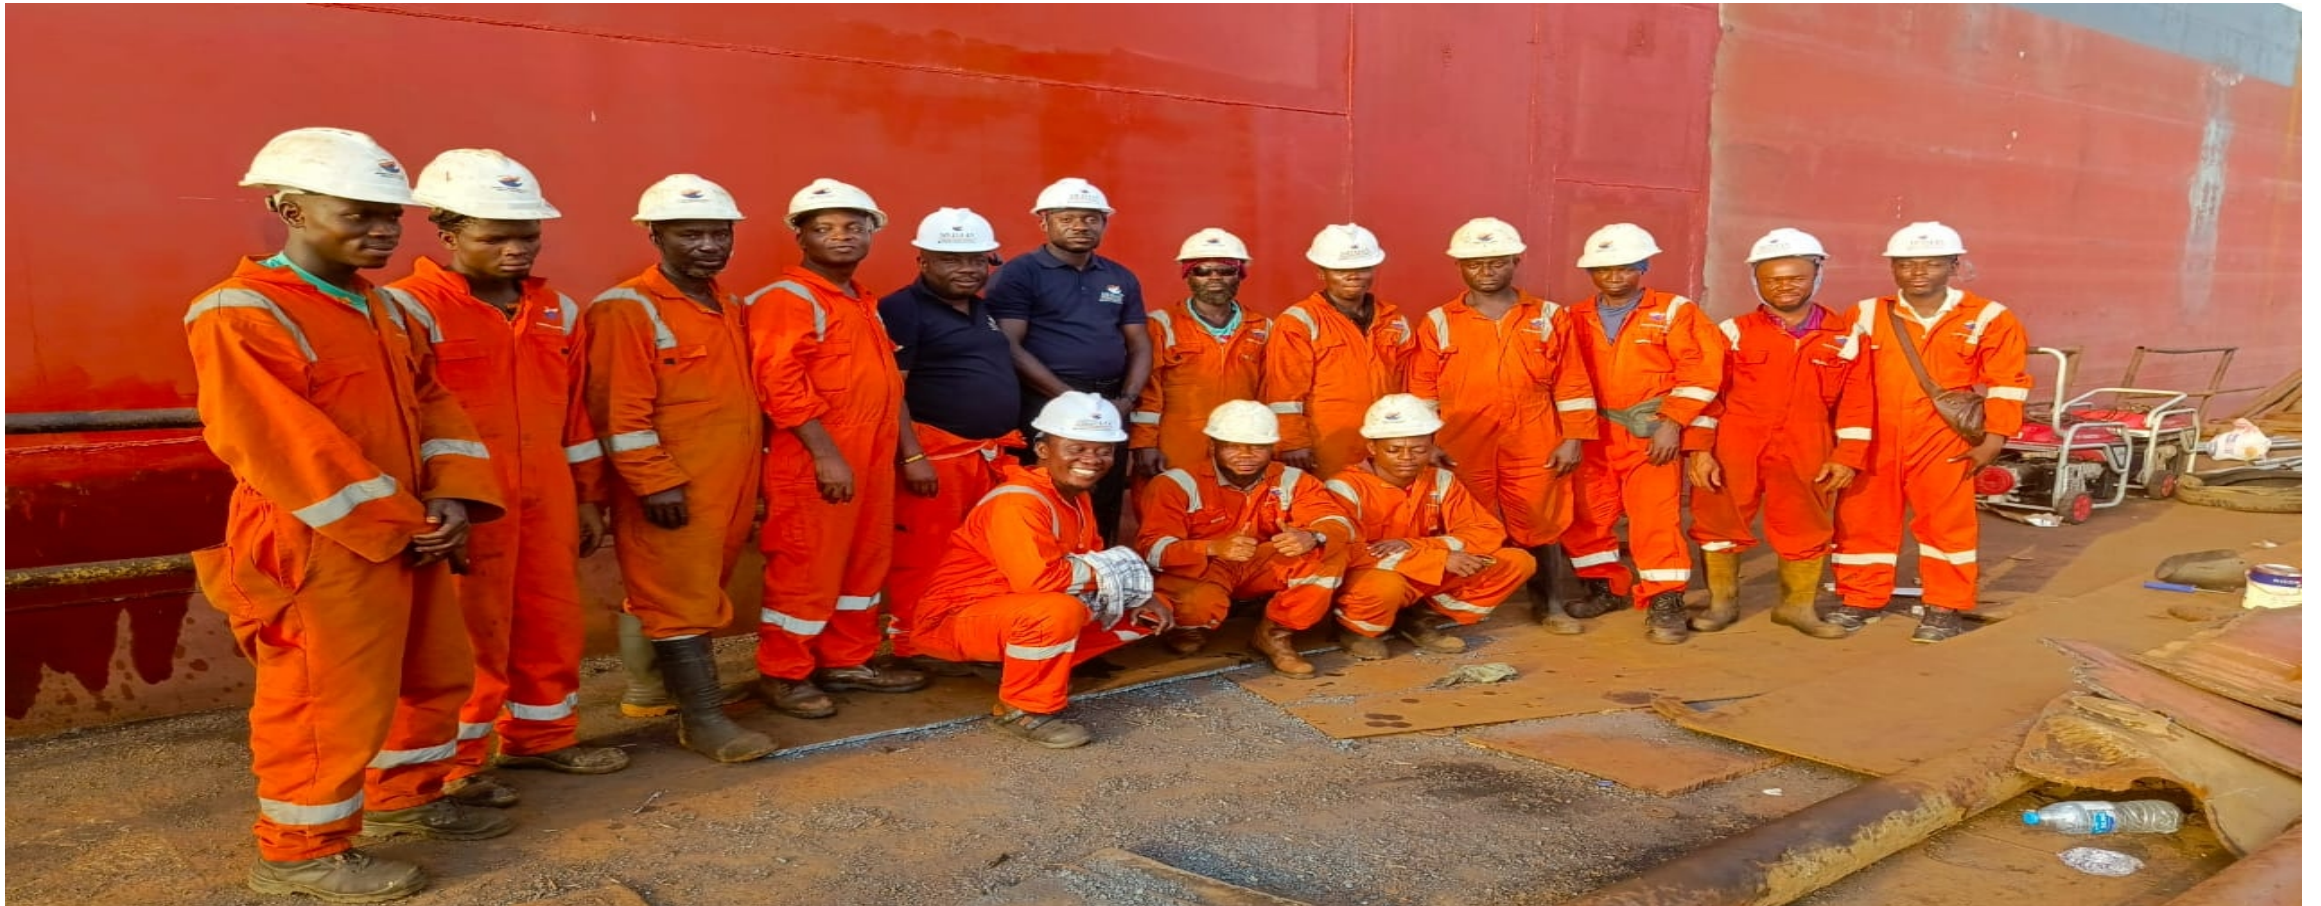
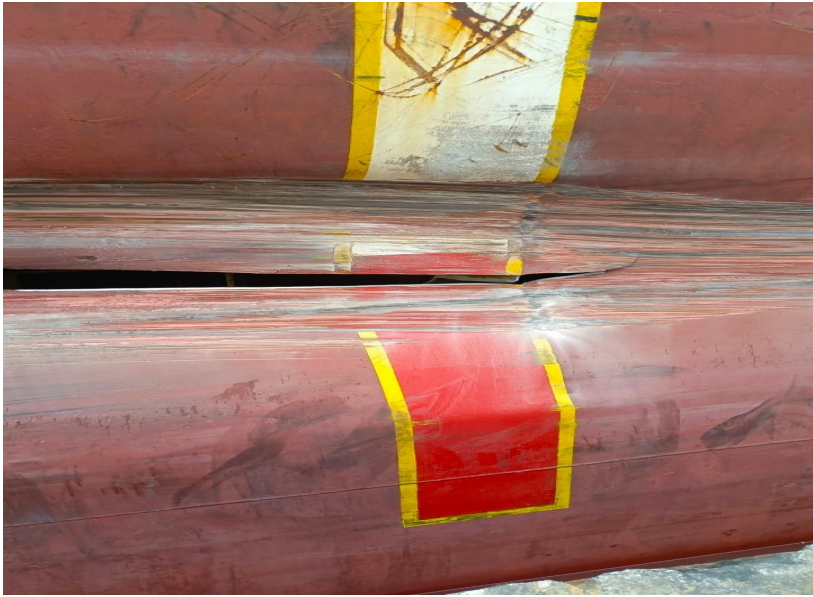
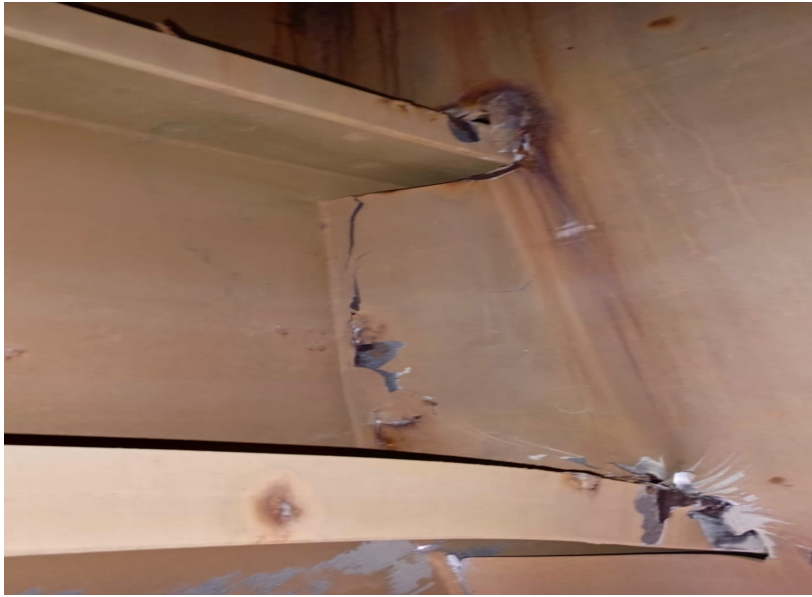
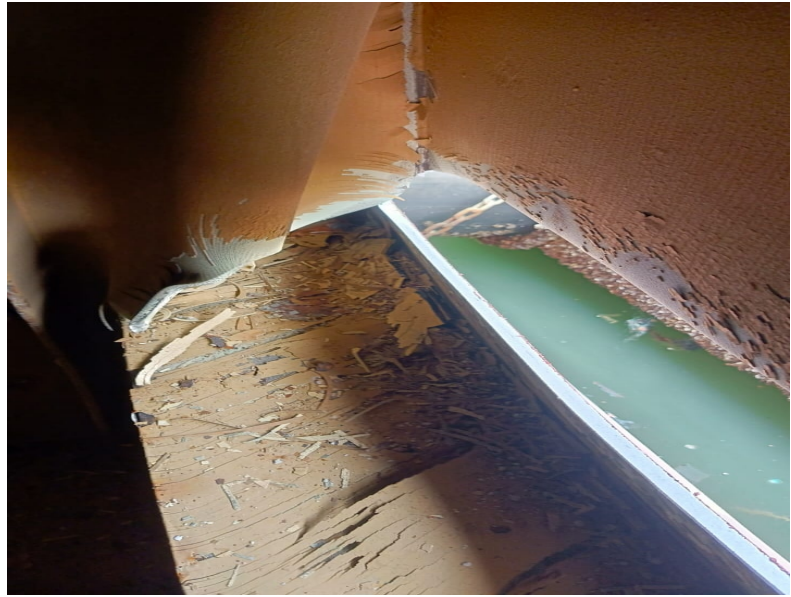
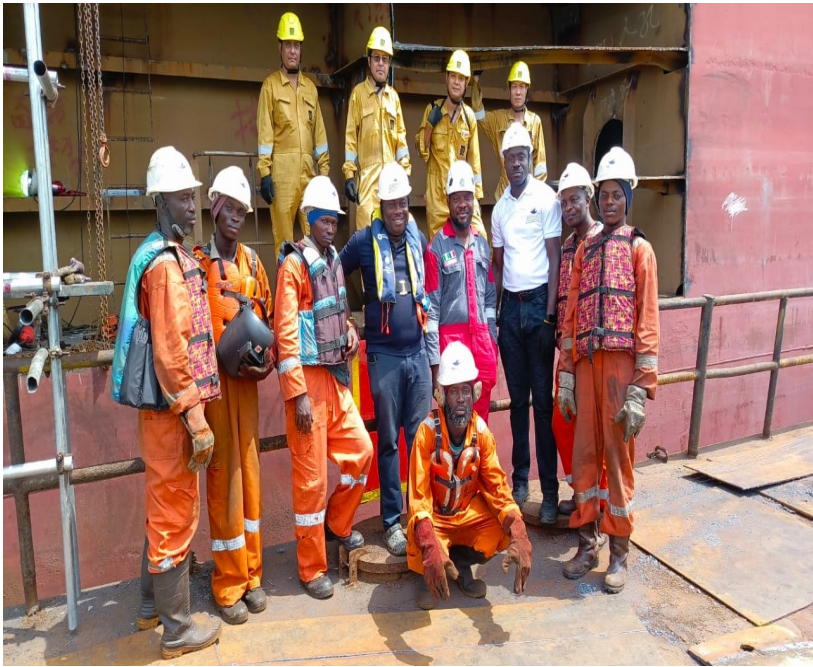
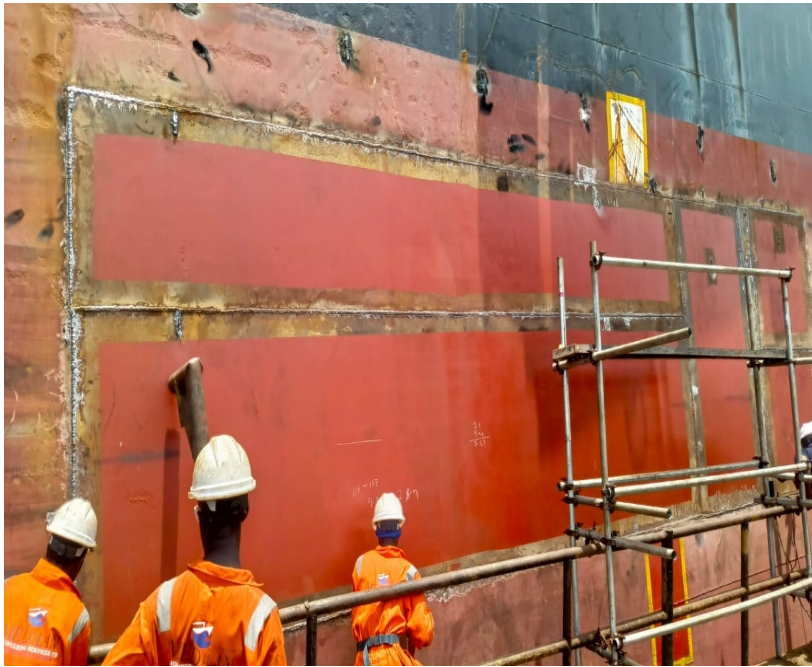
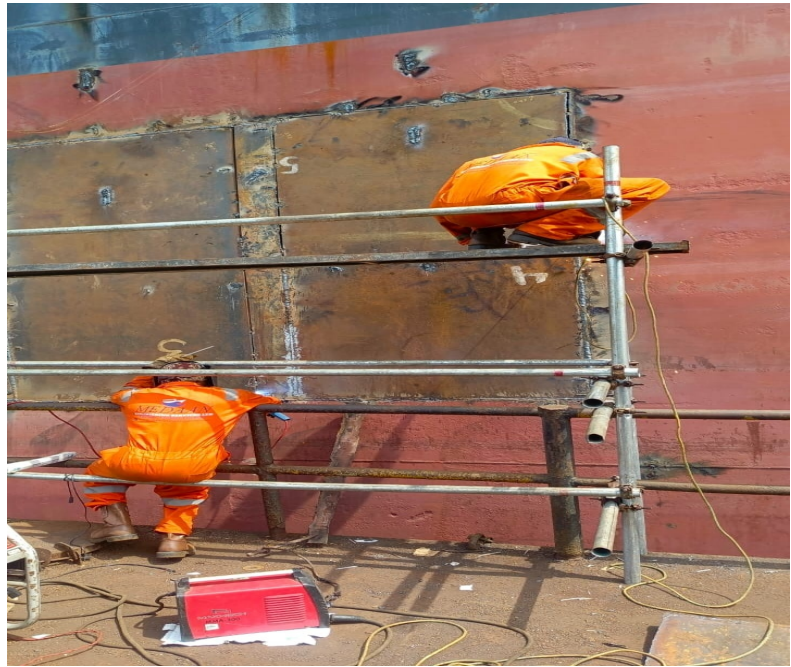
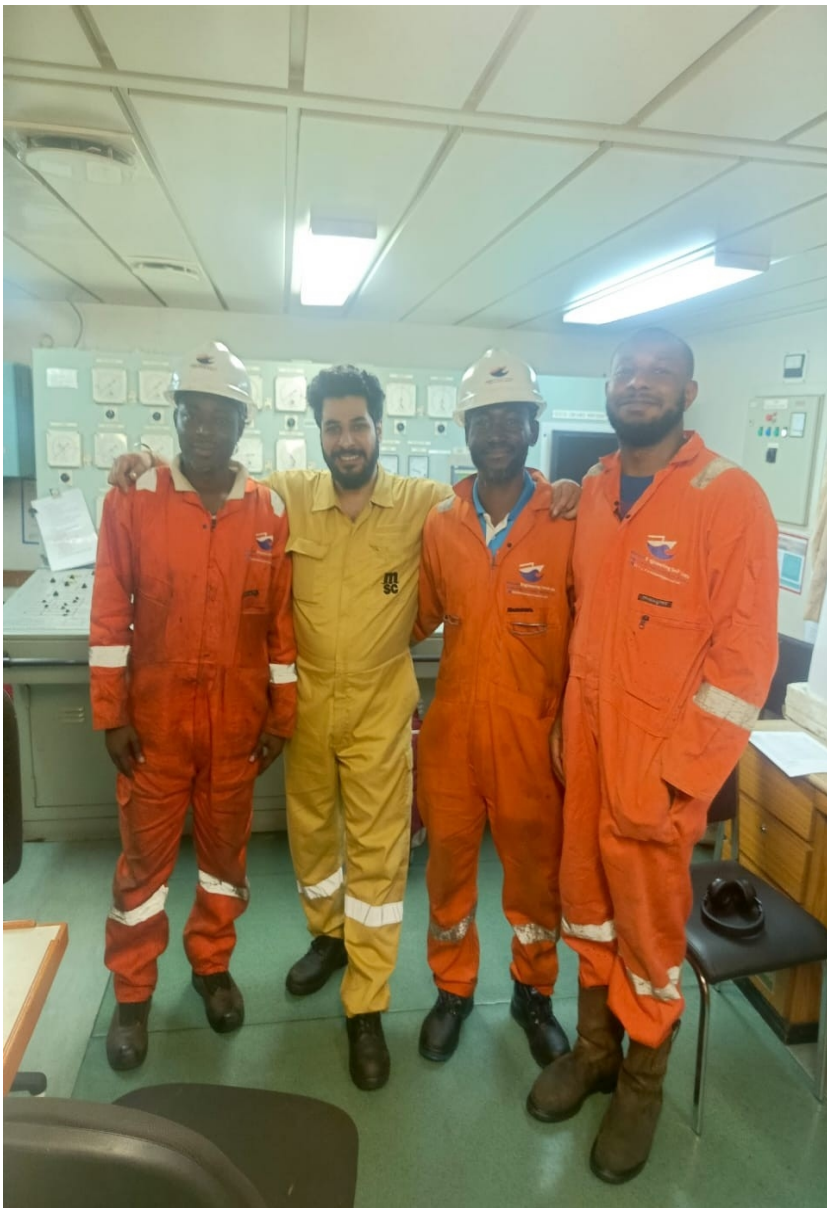
**Project Title: SEA WATER PIPES REPAIRS**  
**Project Location; SAN PEDRO /ABIDJAN**  
**Date Completed: 9<sup>TH</sup> MARCH,2025**  
**Customer Name: CONTAINER CARGO VESSEL**

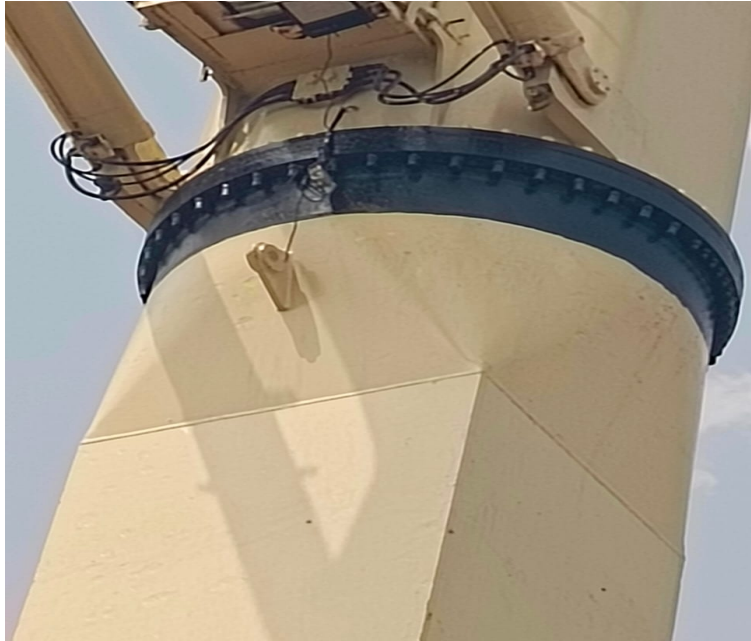
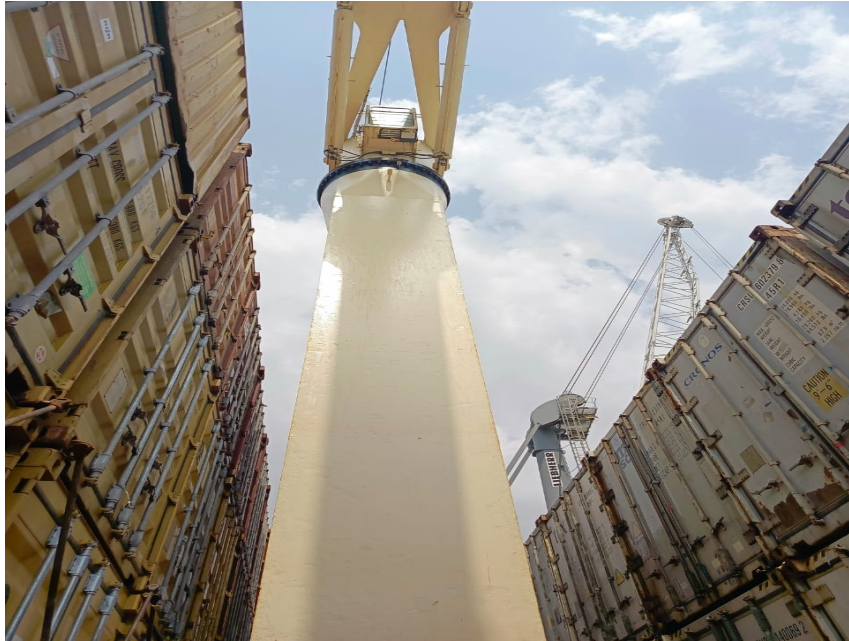
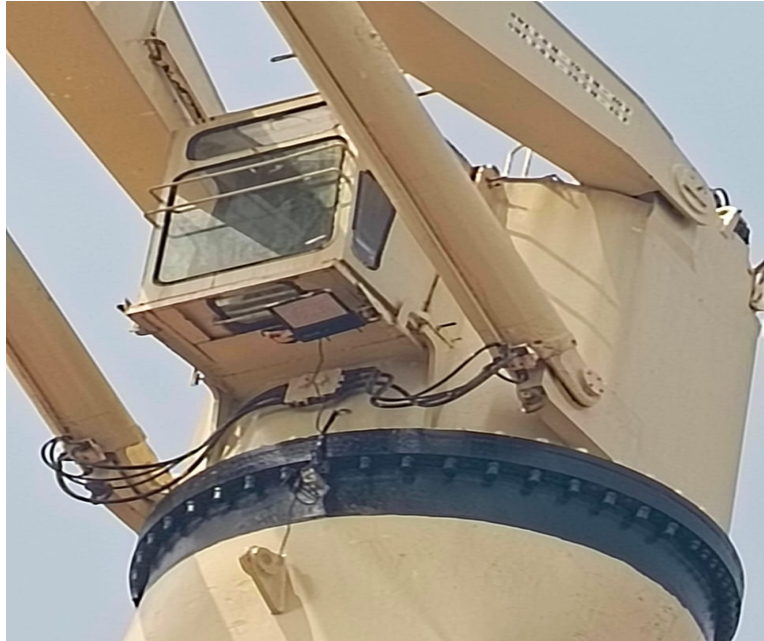
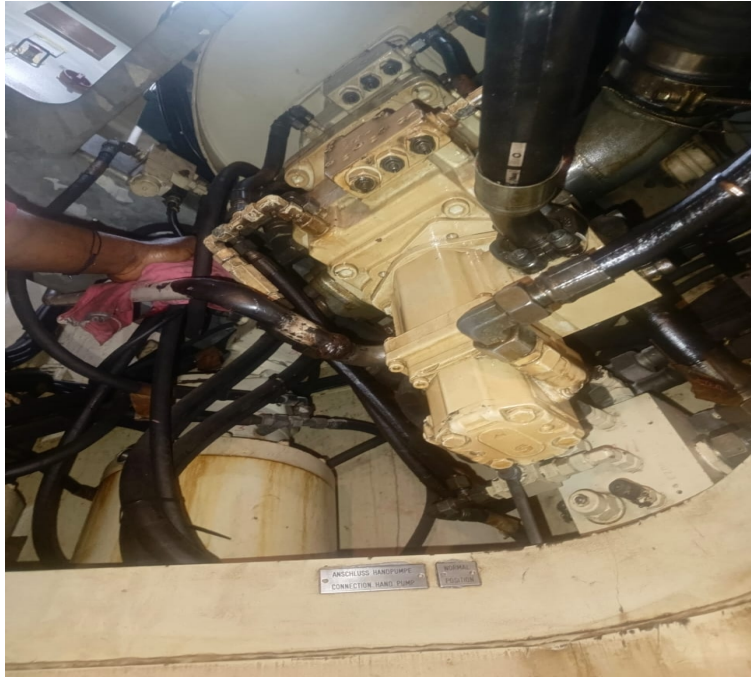
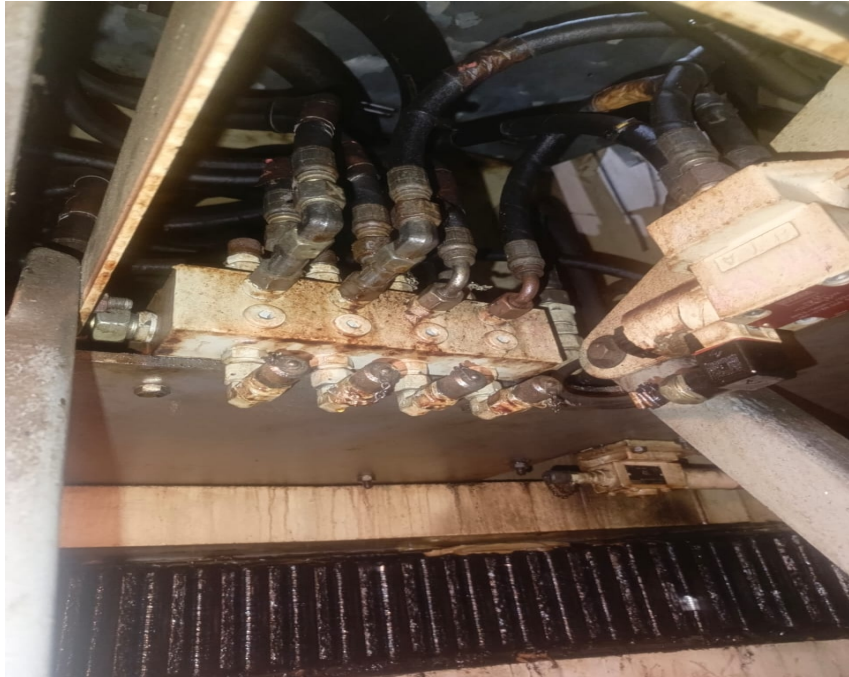
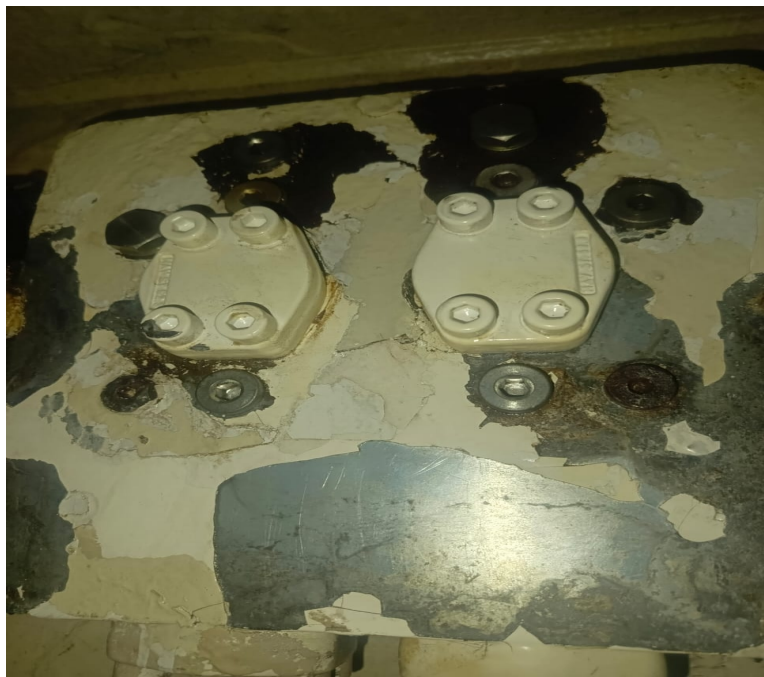
**Project Title: DECK CRANE1,2,&4 REPAIRS**  
**Project Location; MOZANBIQUE**  
**Date Completed: 23<sup>TH</sup> August,2024**  
**Customer Name: CONTAINER CARGO VESSEL**

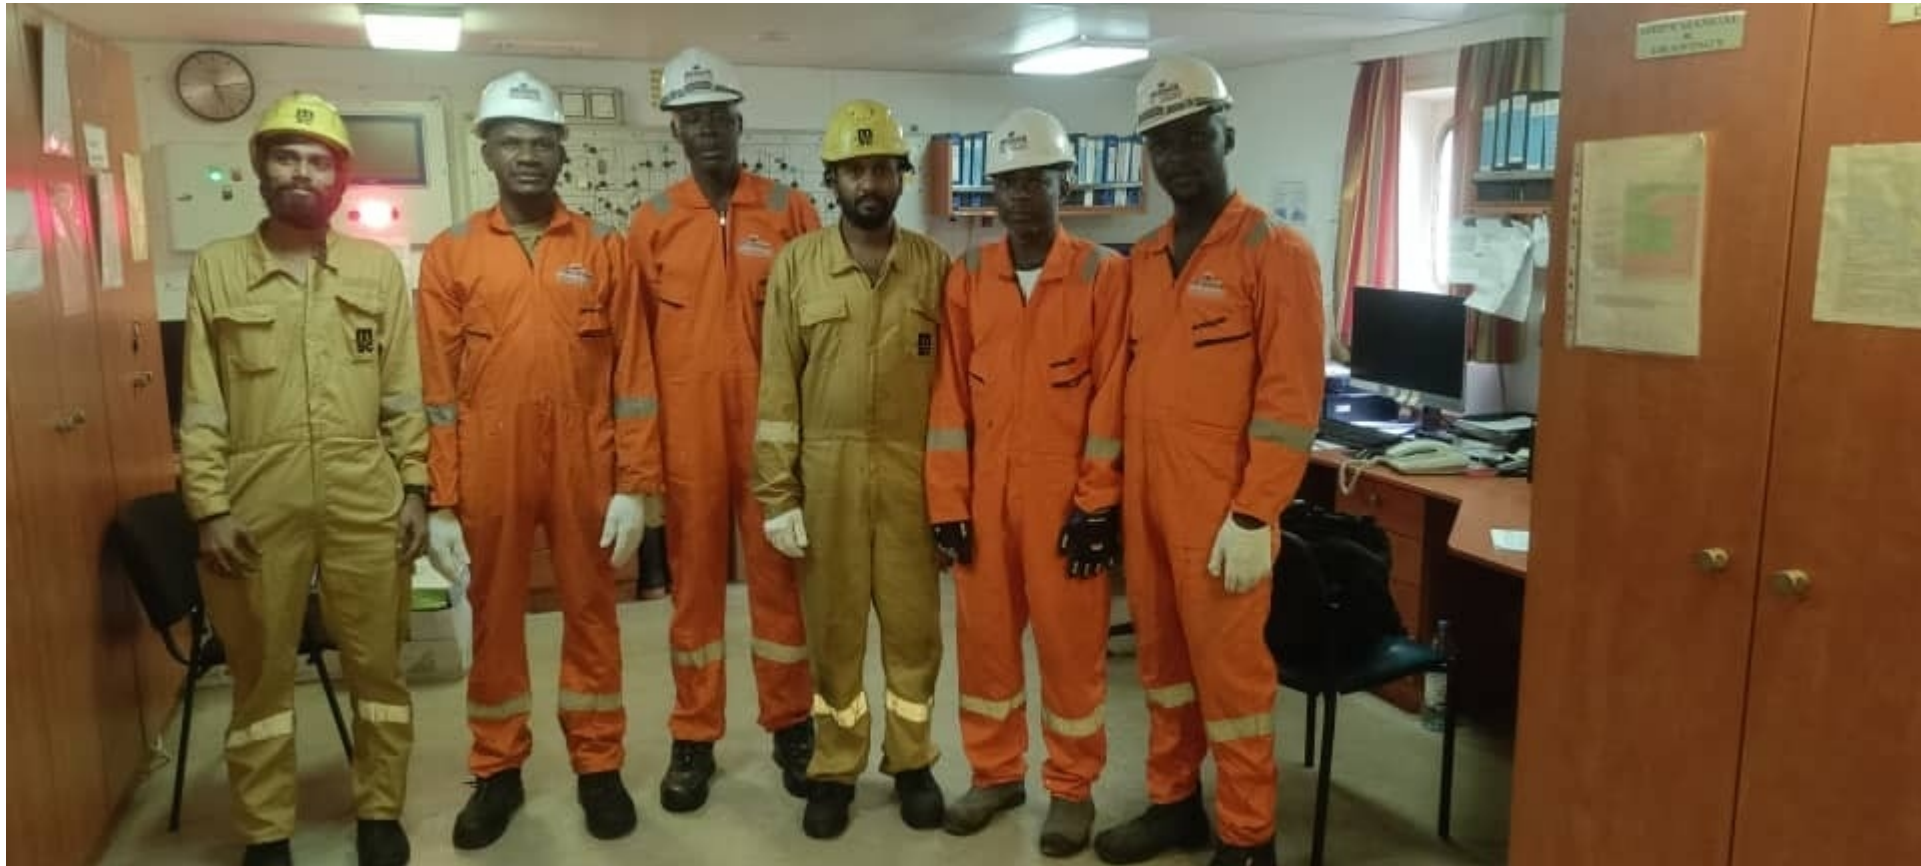
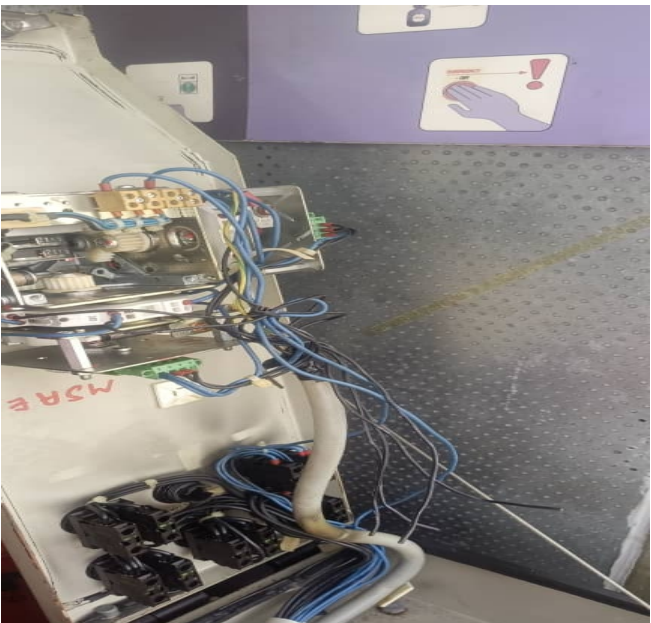
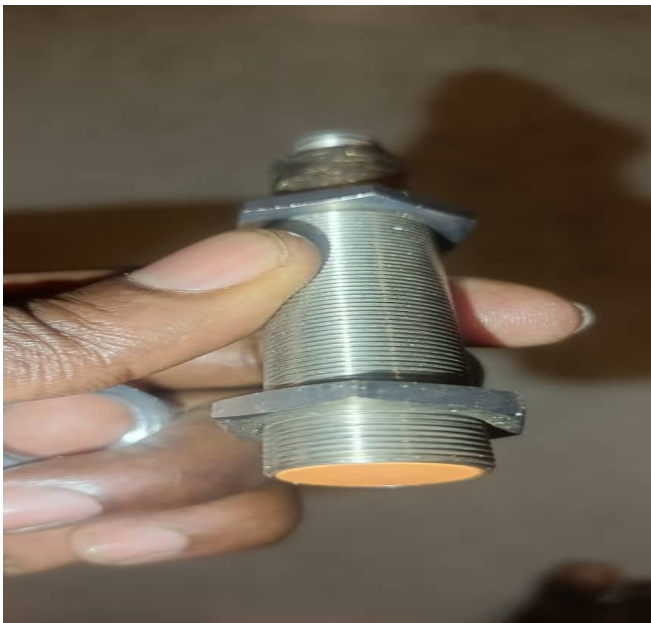
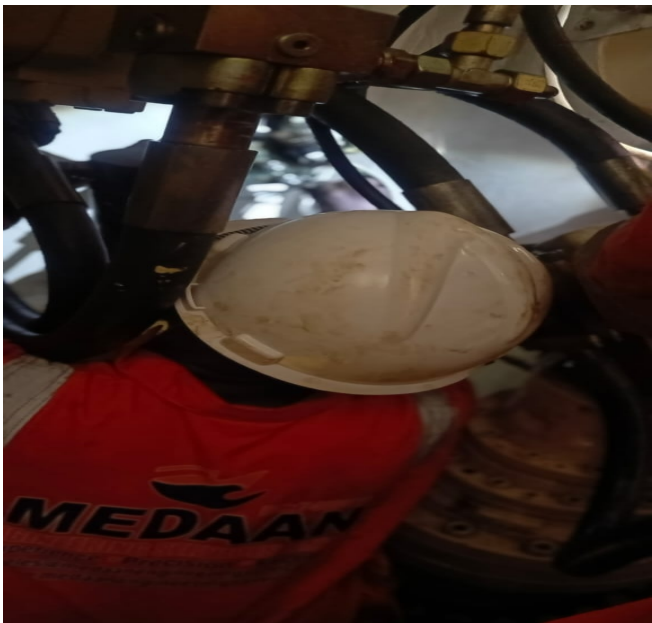
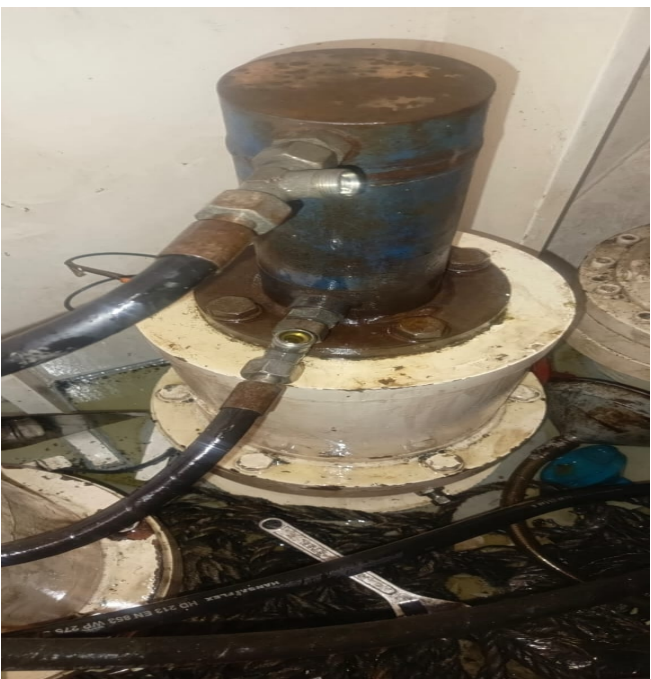
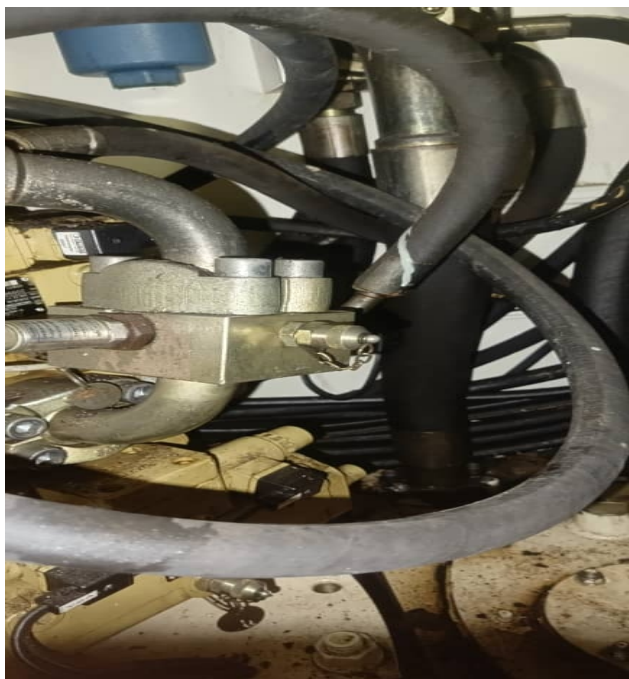
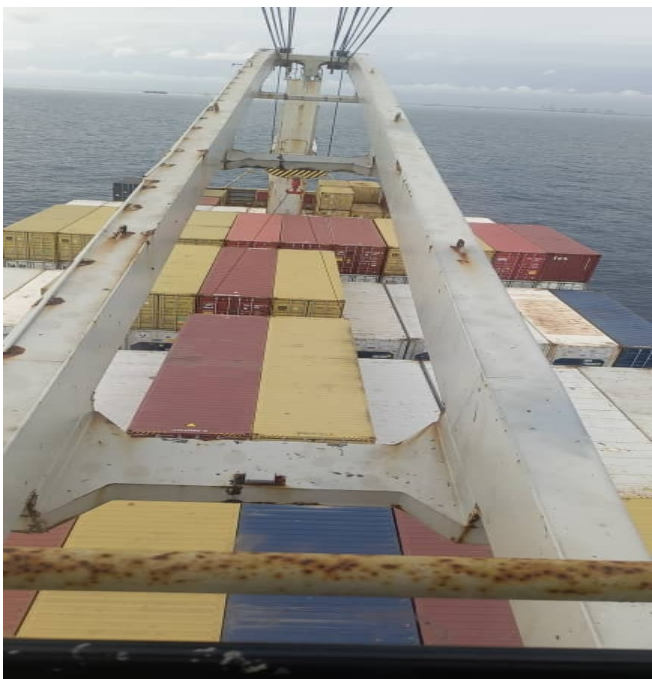
**Project Title: DECK CRANE 2 REPAIRS**  
**Project Location; LOME**  
**Date Completed: 30<sup>TH</sup> APRIL,2026**  
**Customer Name: CONTAINER CARGO VESSEL**
