# COMPLETED PROJECTS

# MEDAAN SERVICE REPORT ON MSC DIAMON 11 REFEER PROVISION STORE REPAIR.

ACTIVITY REPORT FOR MSC HAITI II REPAIRS IMO: 9225251

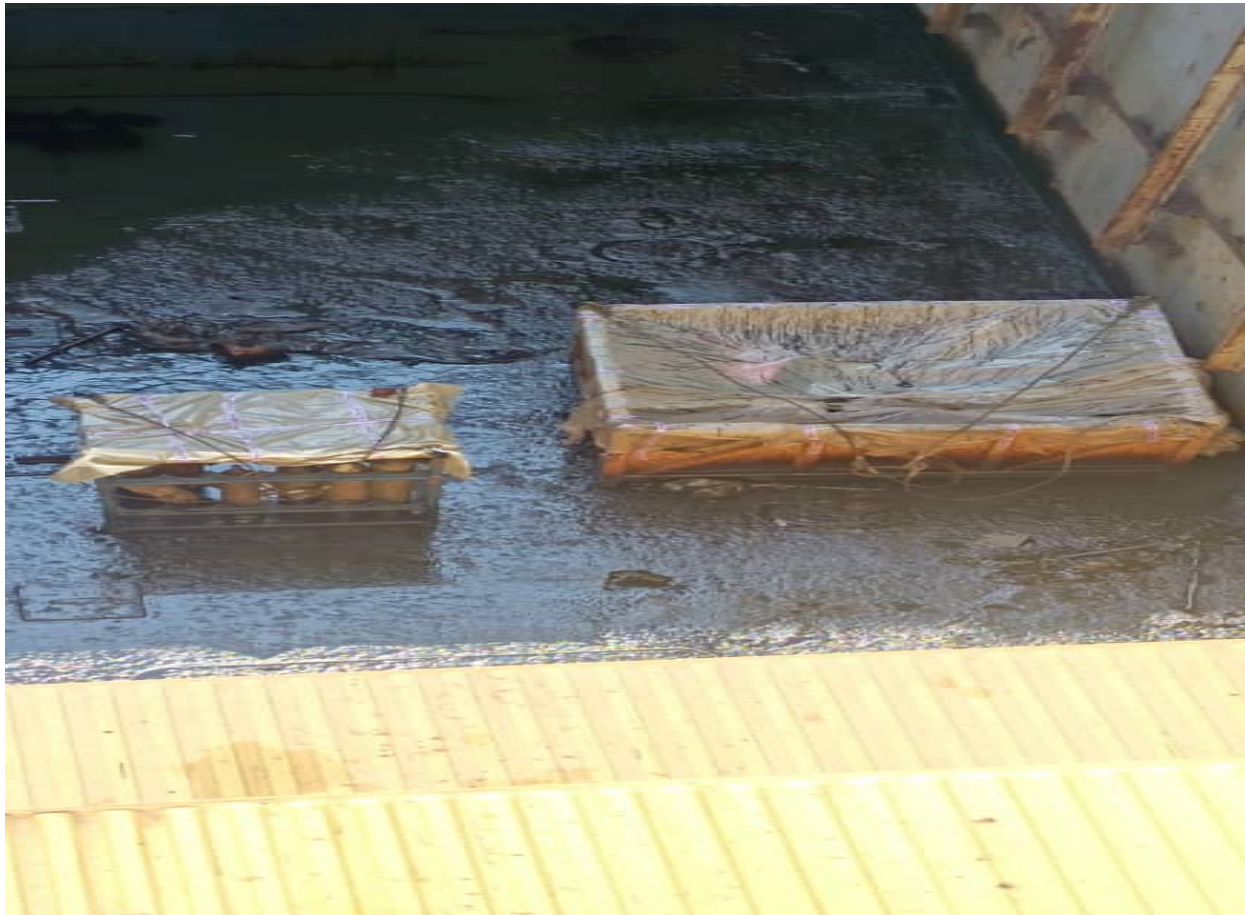
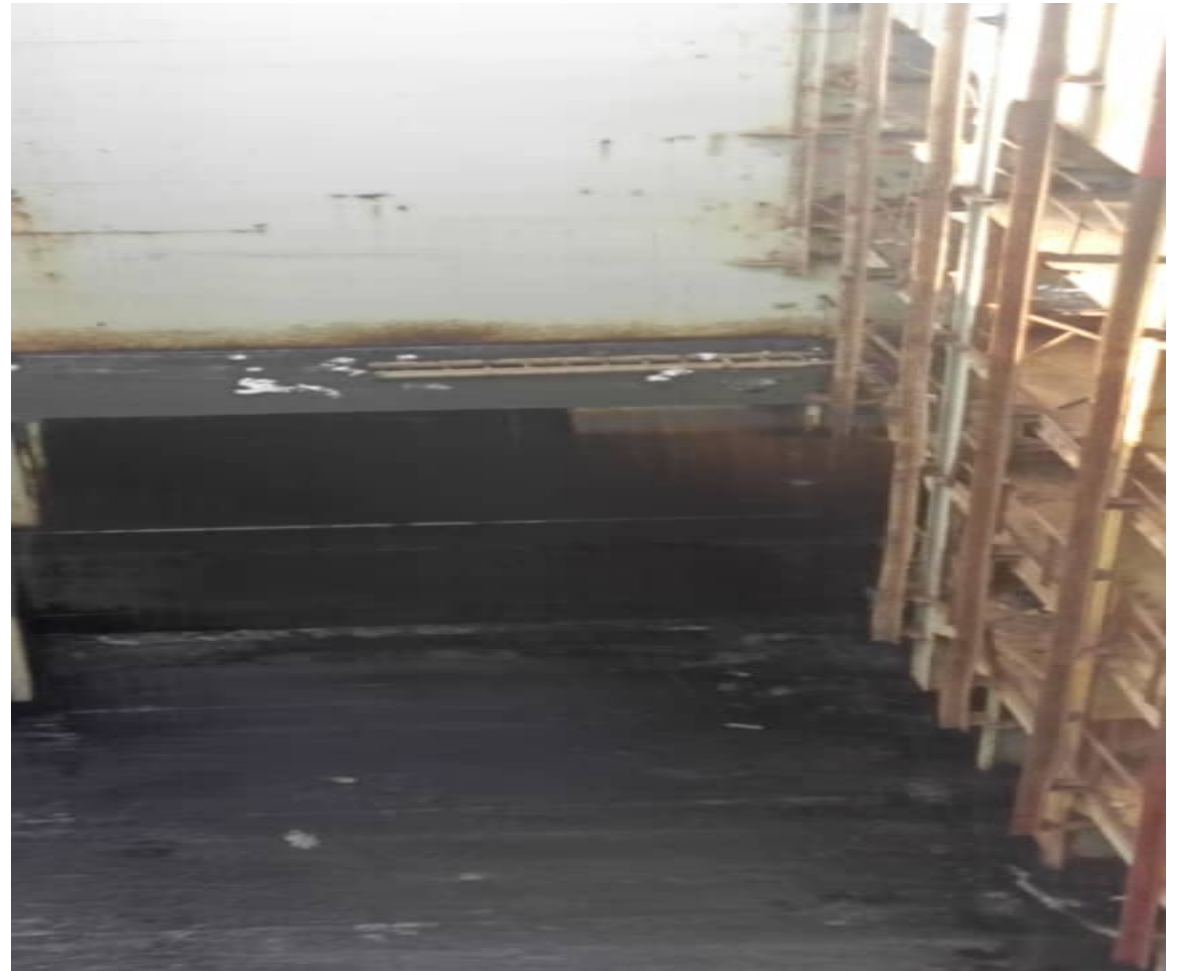
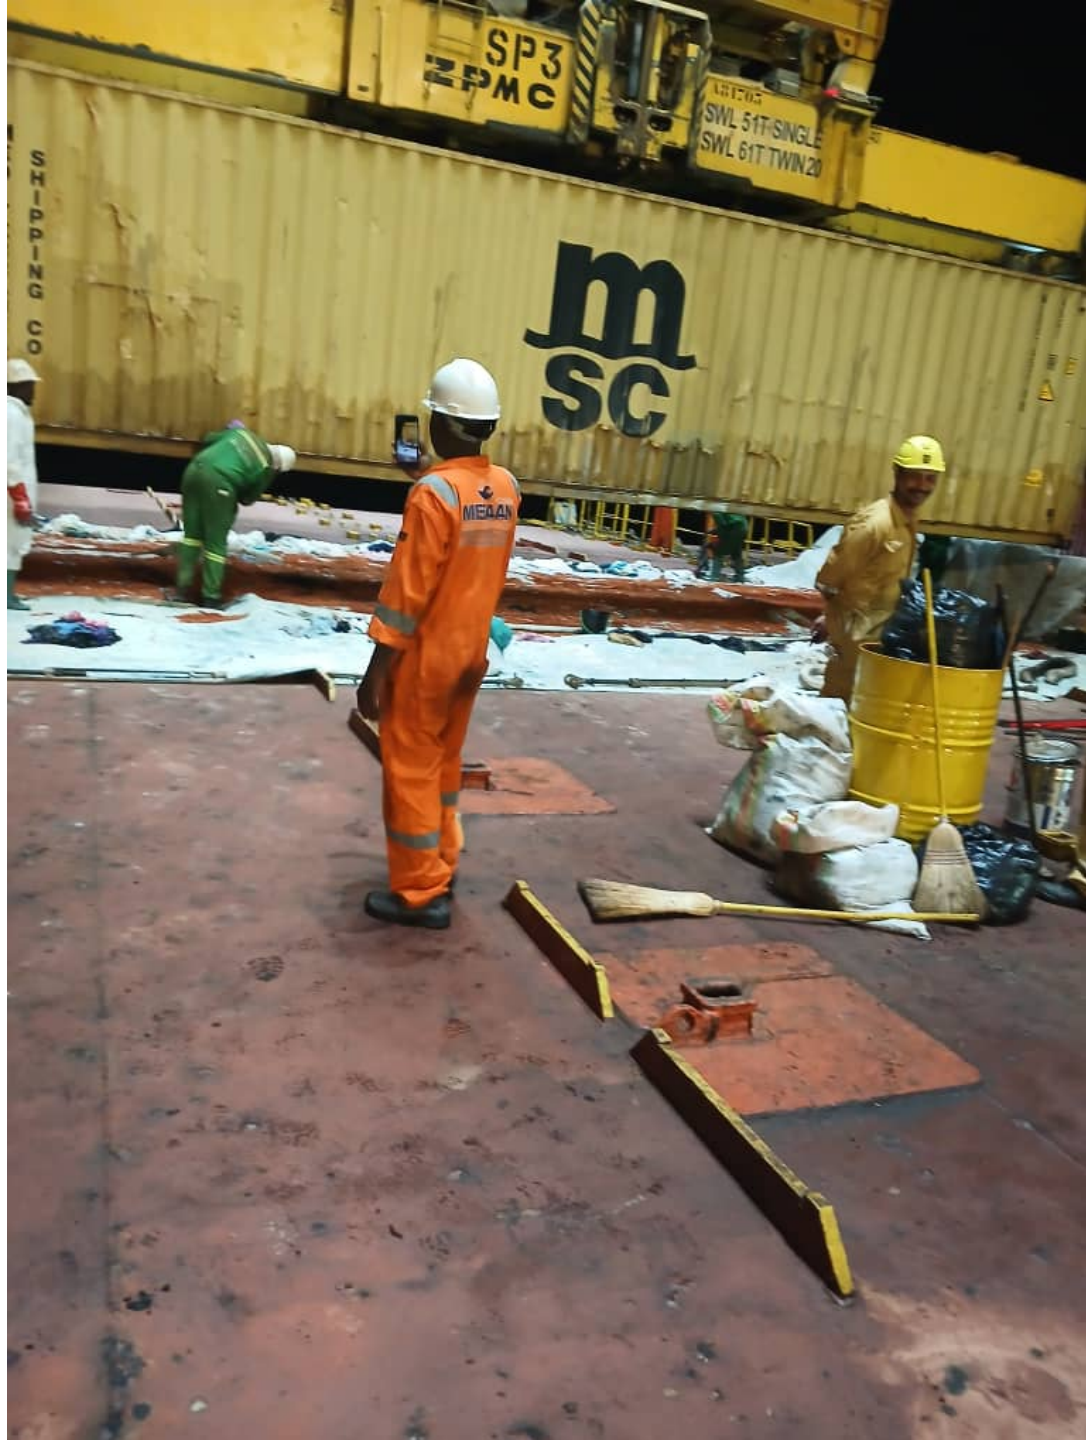
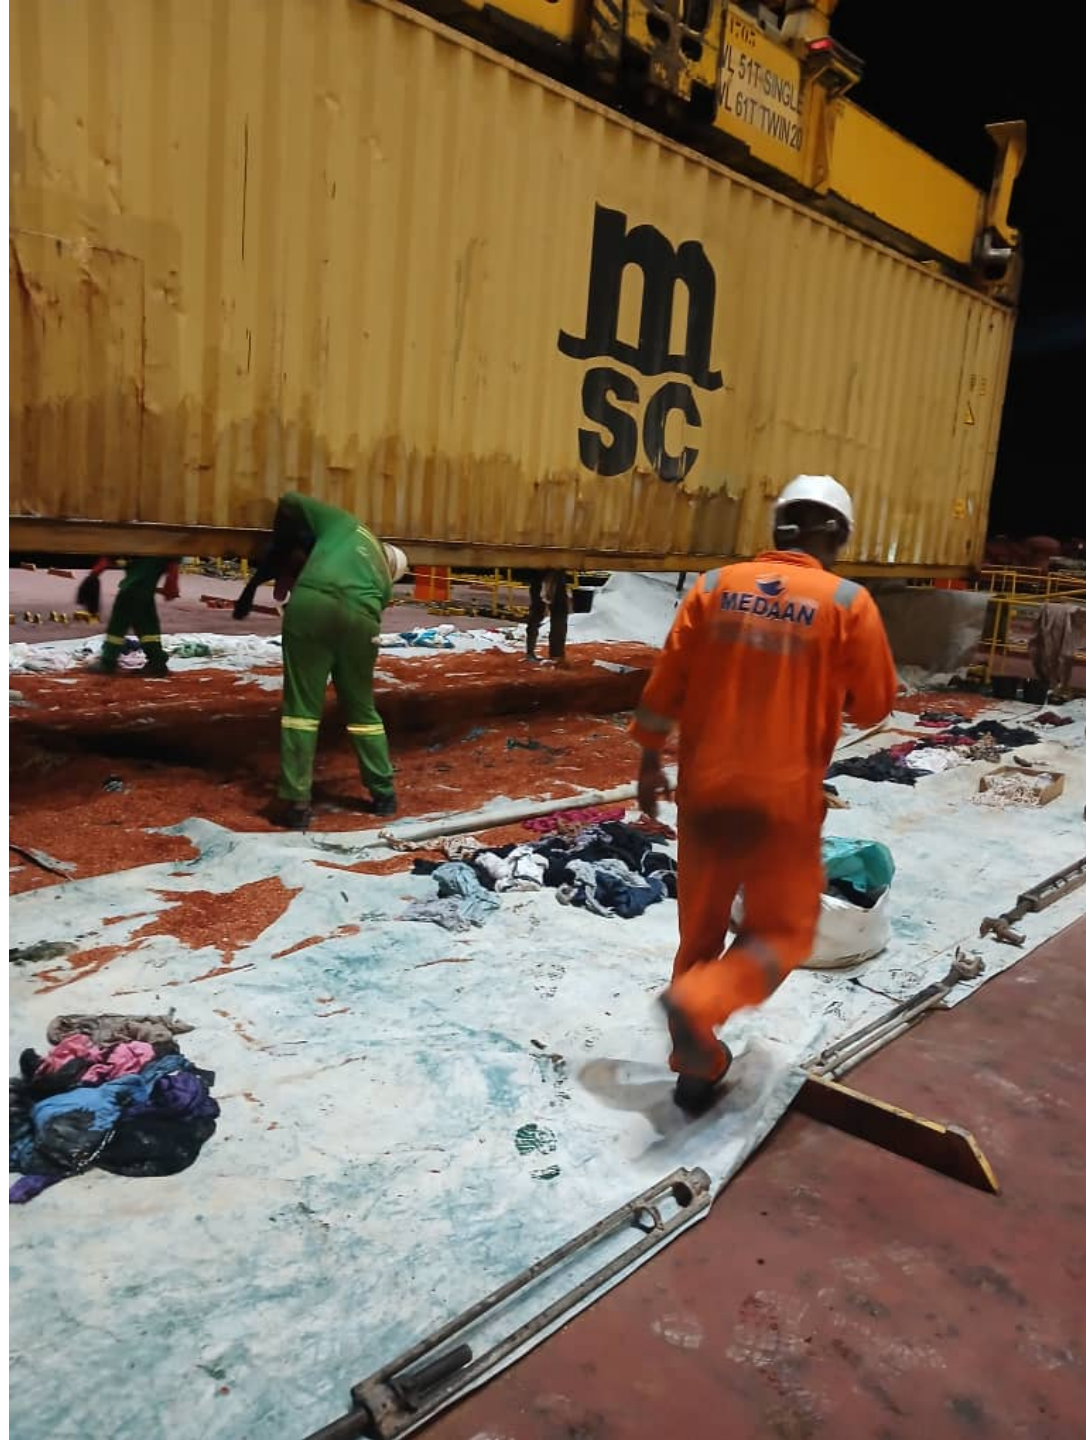
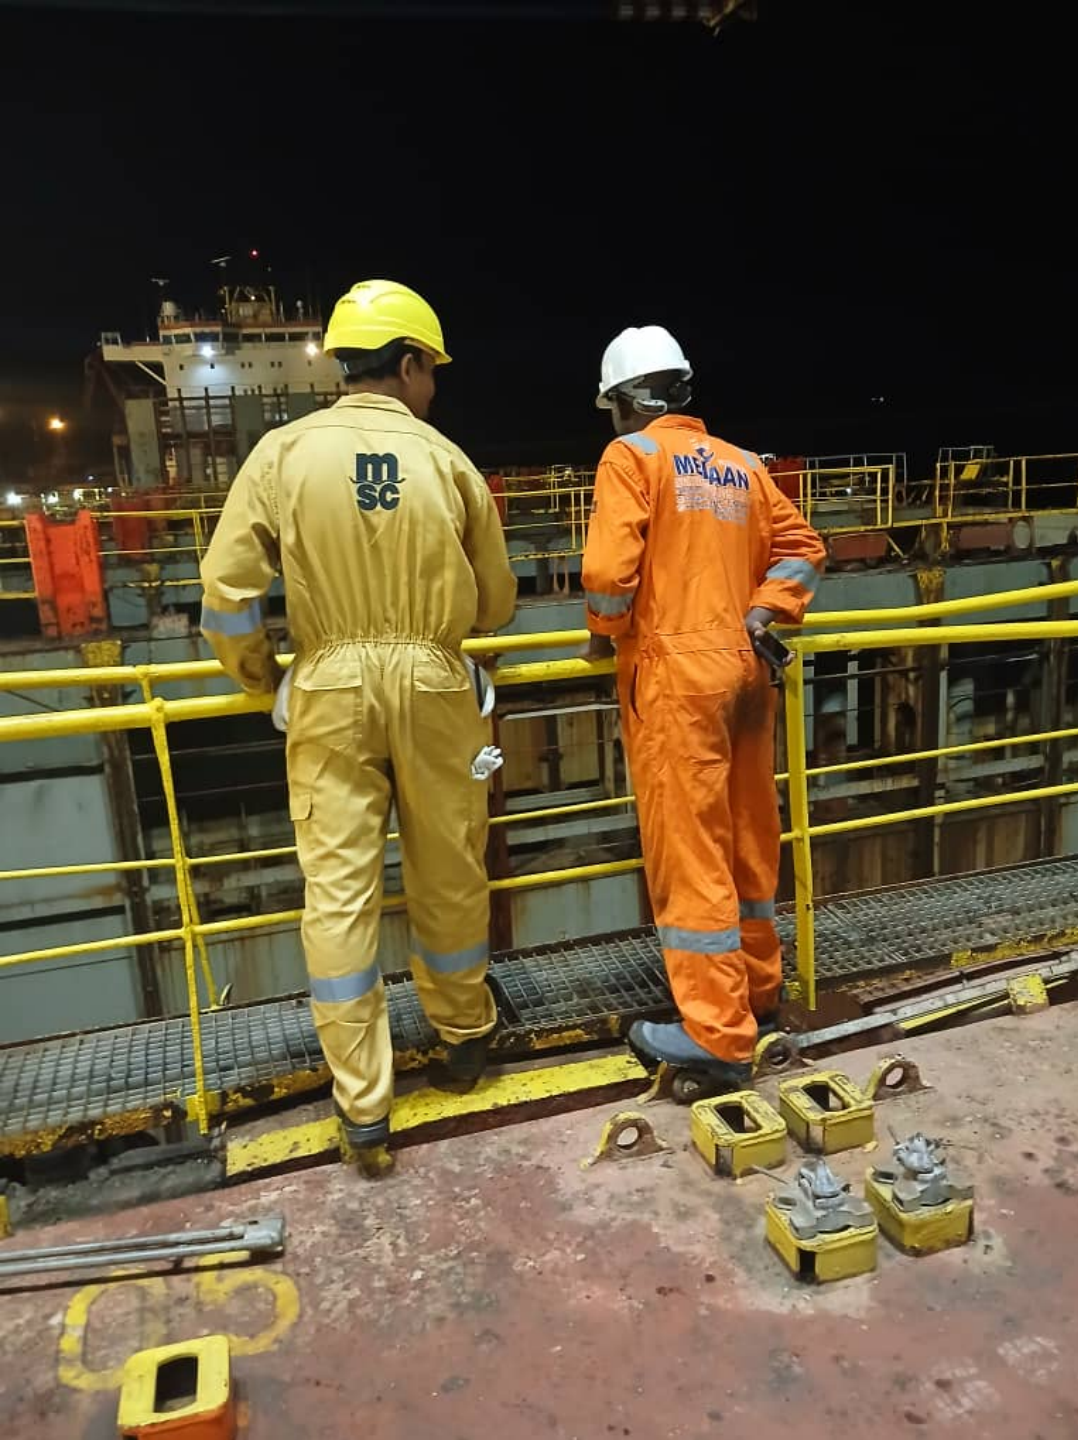
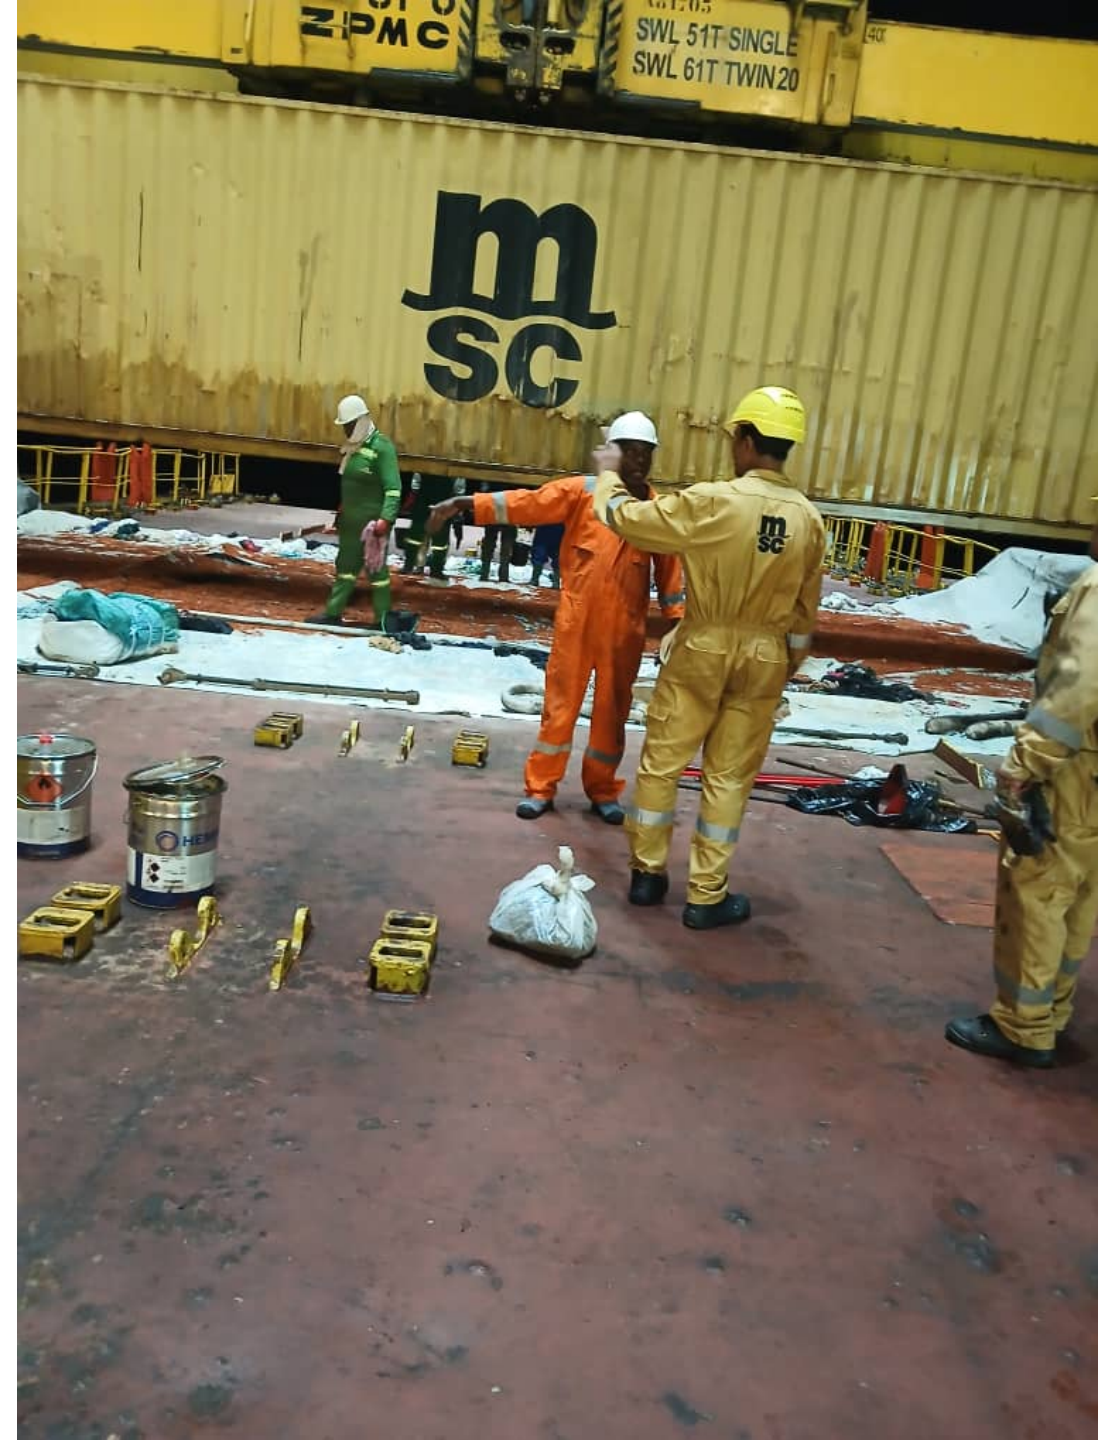
**Project Title: FO TANK NO. 3 LEAKAGE REMEDIATION & CARGO HOLD RECOVERY**

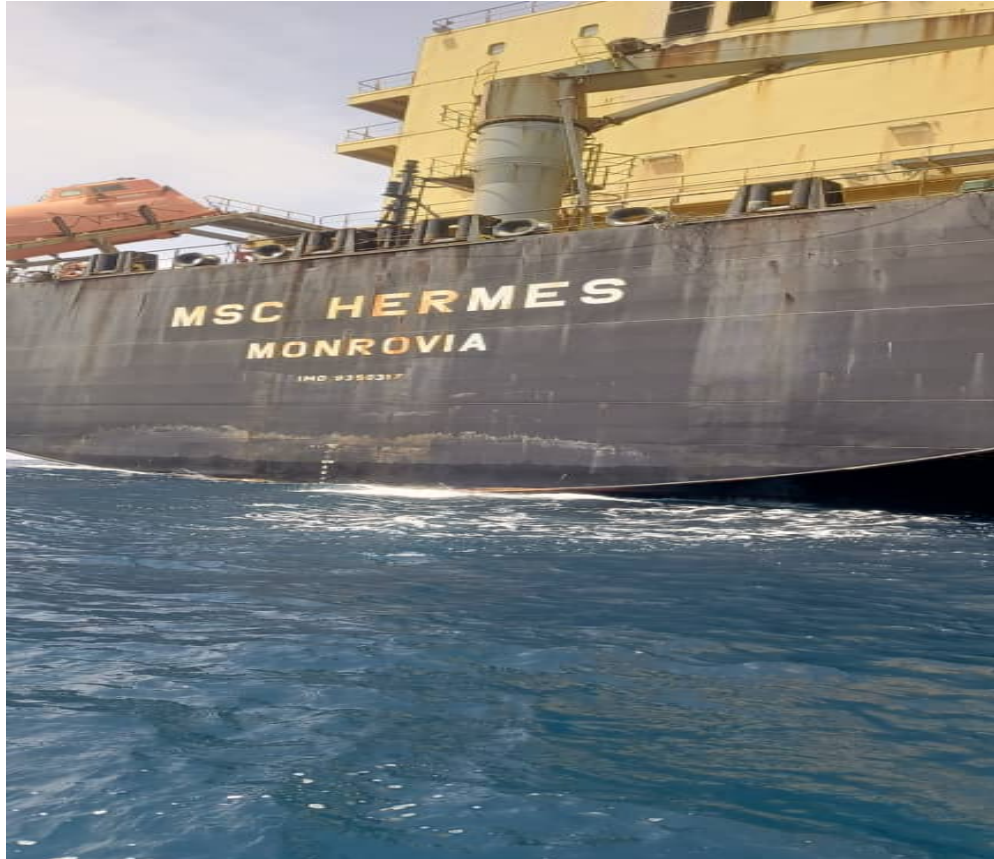
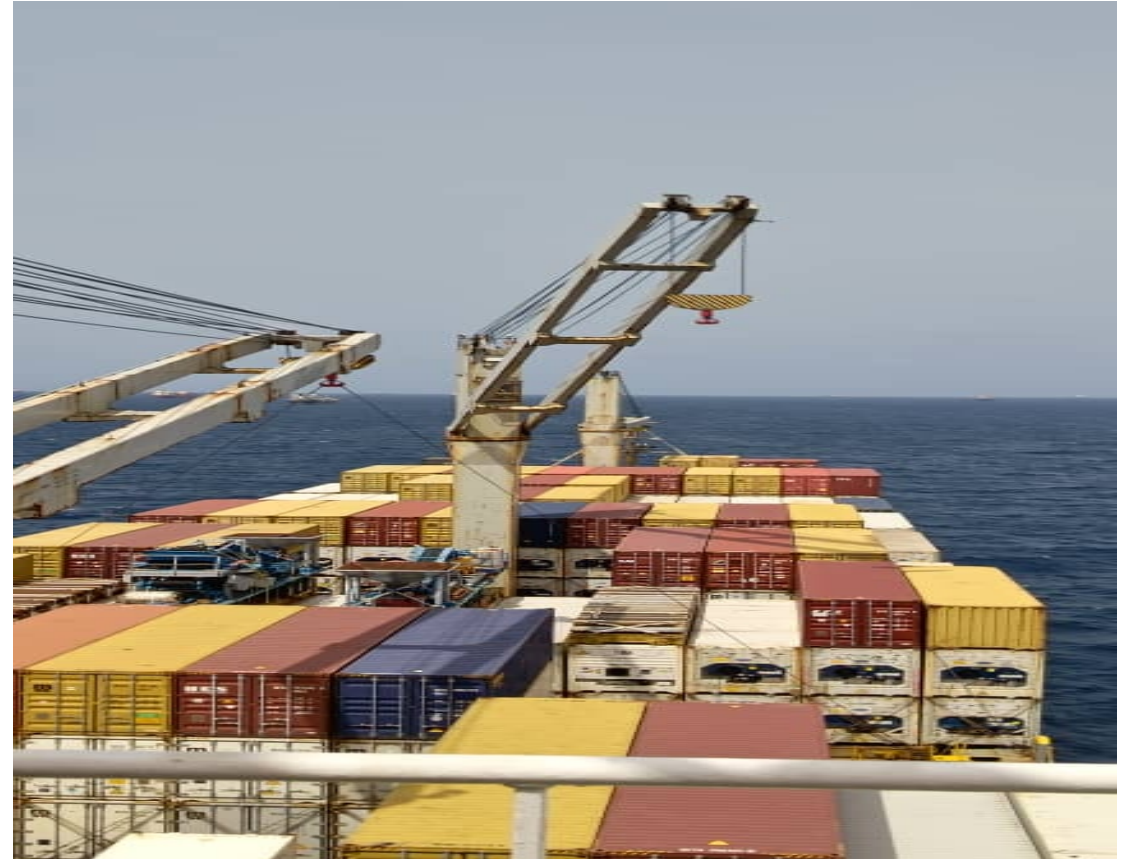
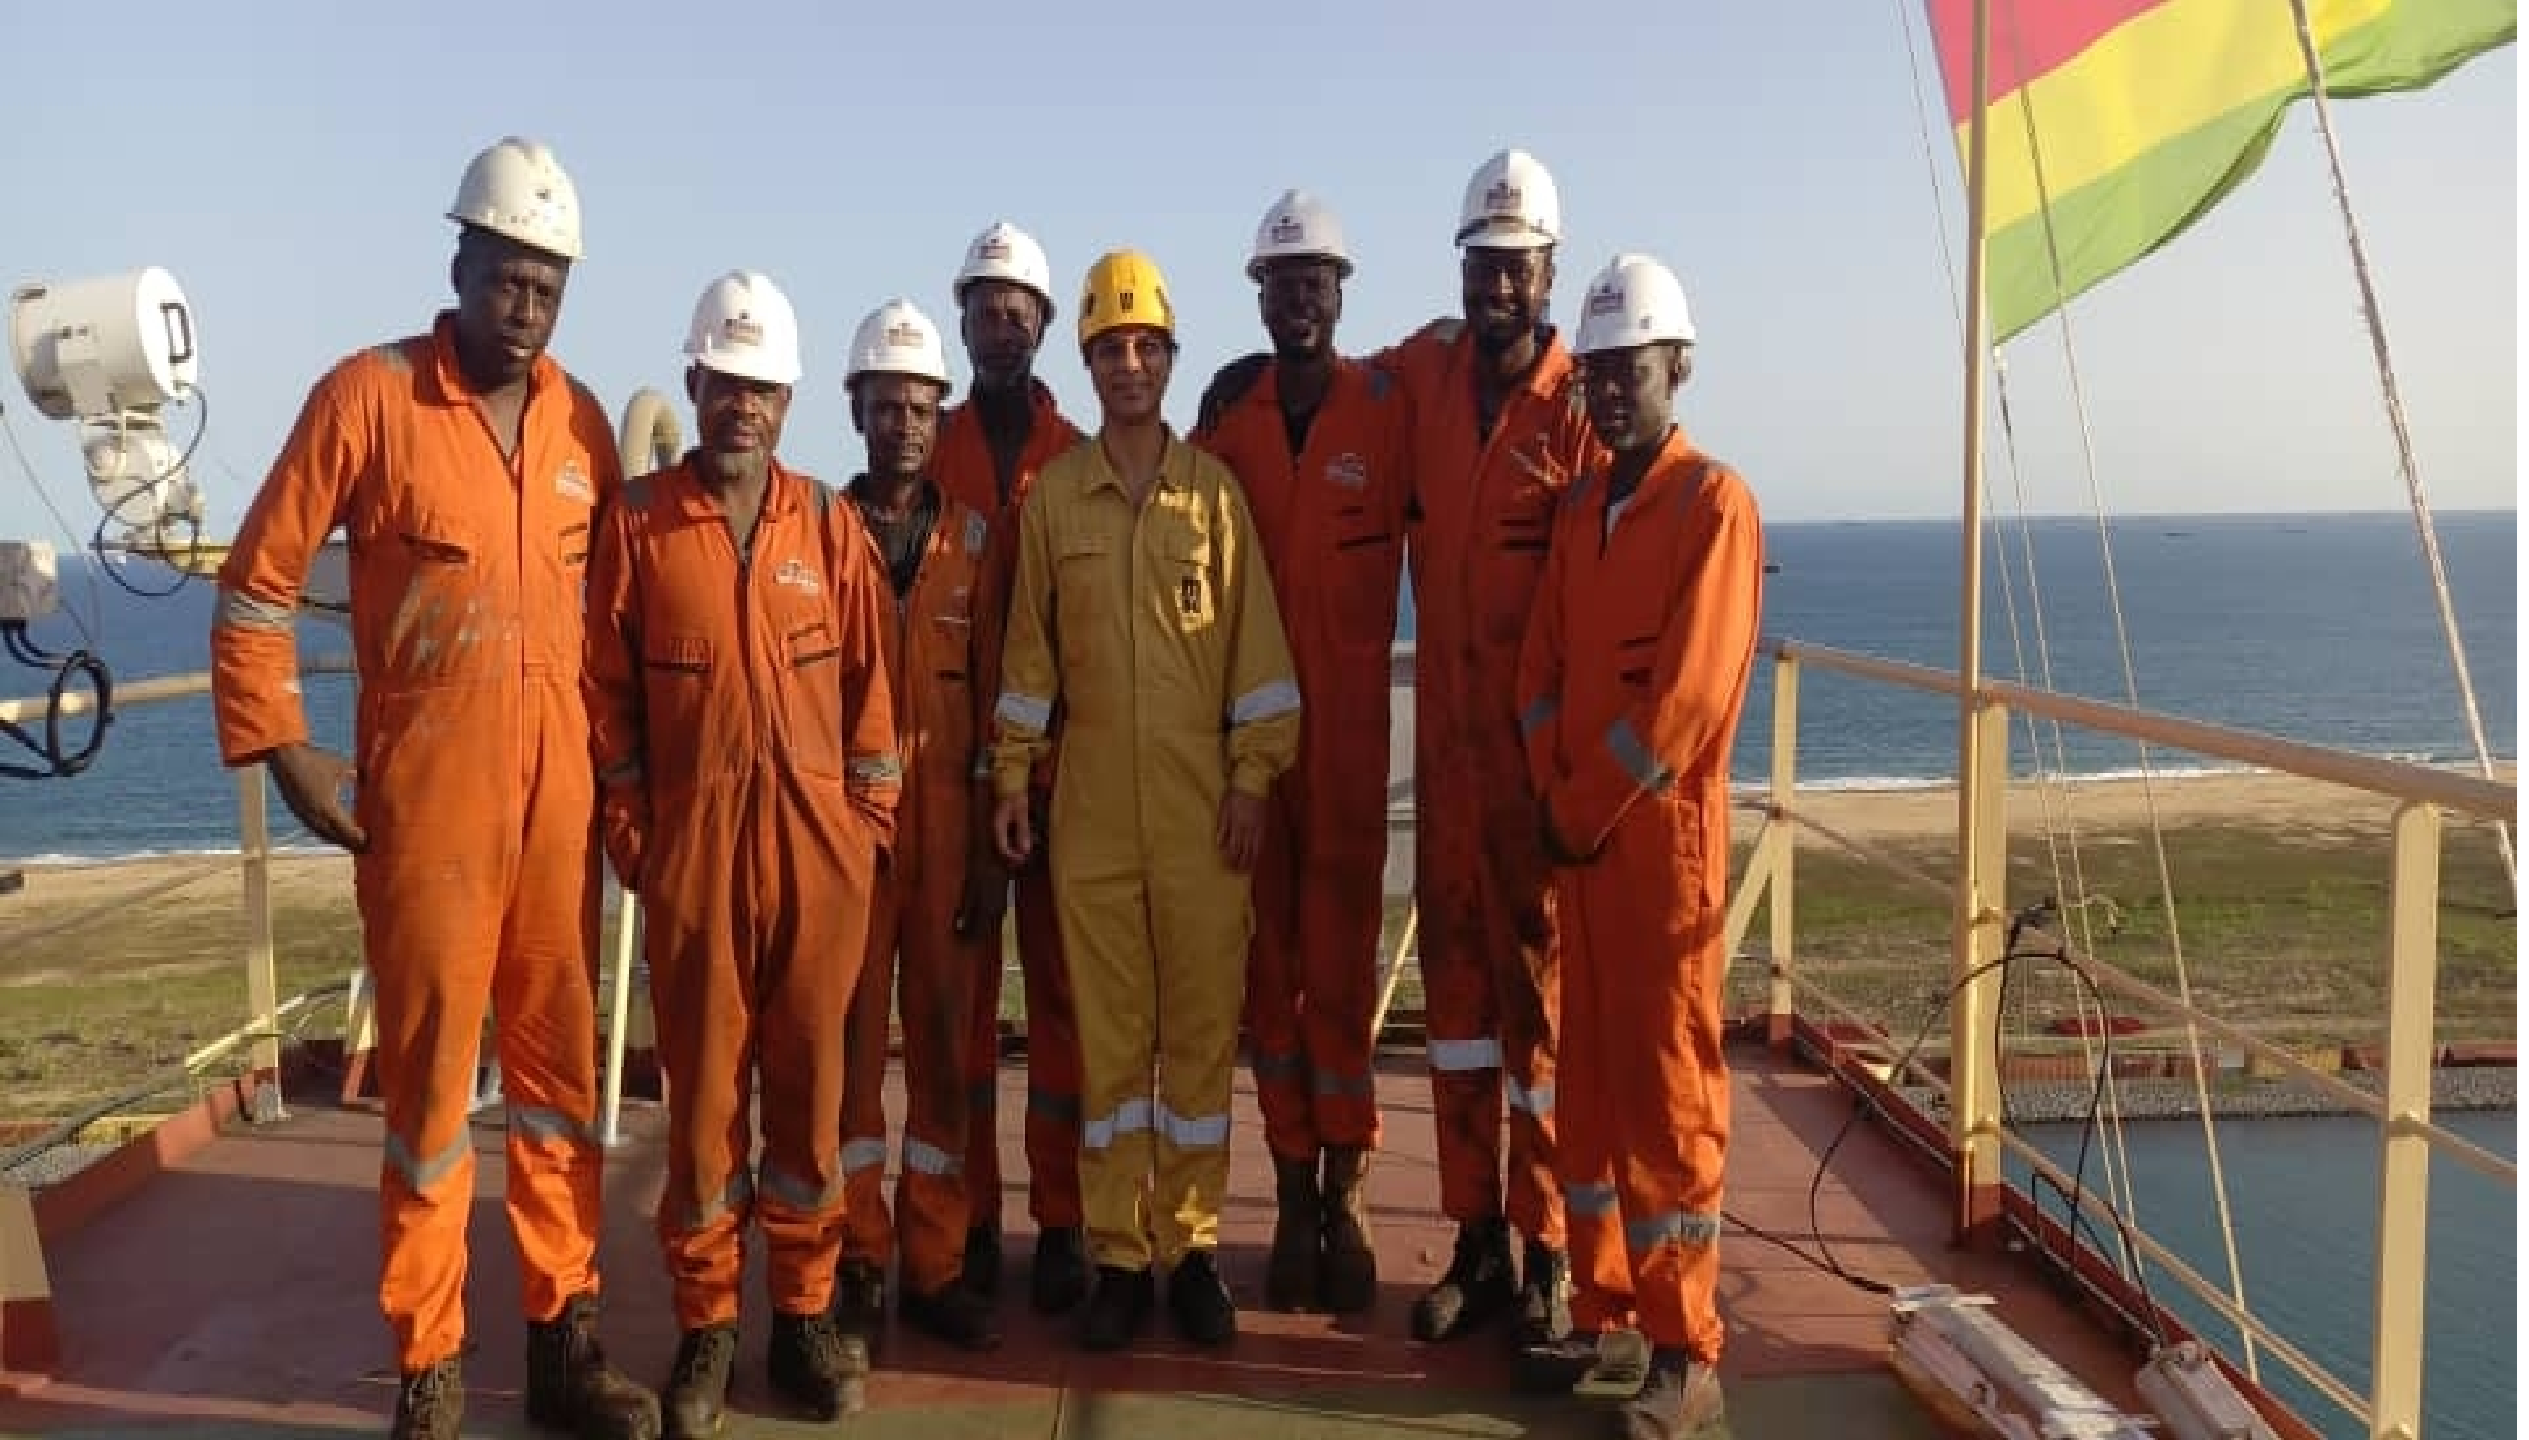
**Project Title: Crane No:2 Restoration**  
**Project Location; Lome Anchorage**  
**Date Completed: 1ST MAY,2026**  
**Customer Name: CONTAINER CARGO VESSEL**

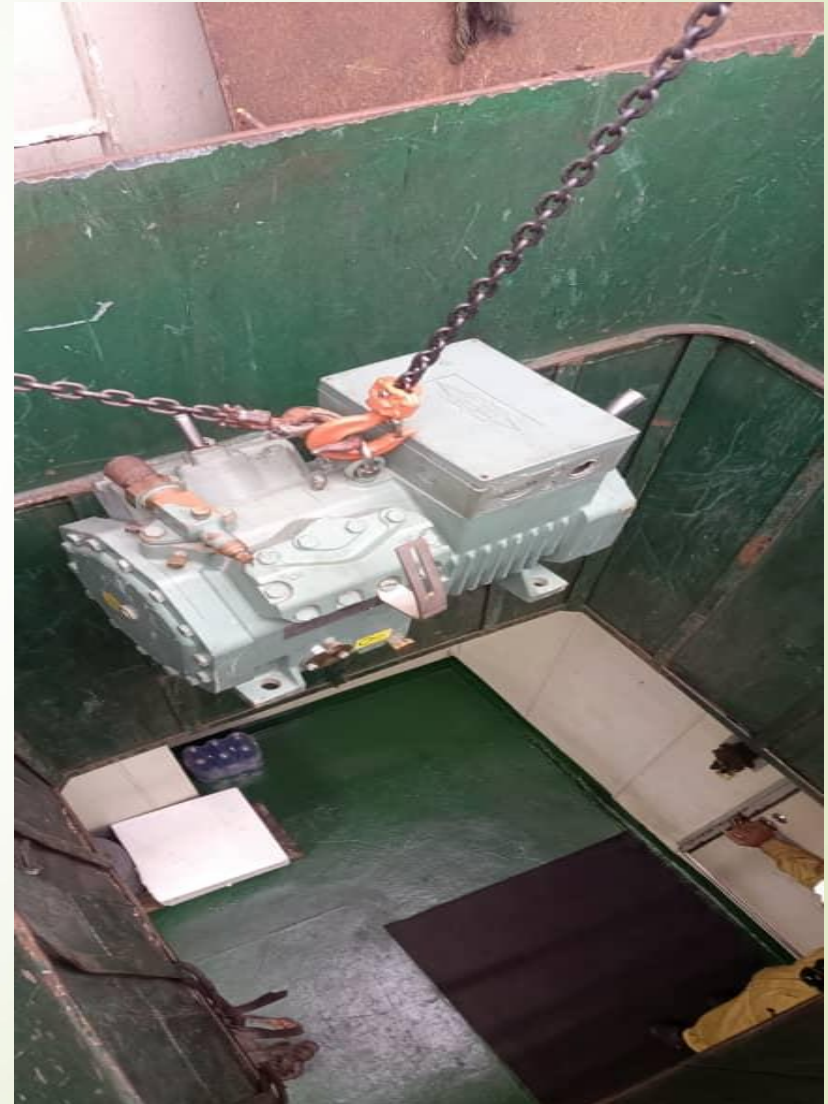
- Compressor 2 not cutting out or start on Auto only starts on Manual mode. ( PLC and HMI problem).
- Compressor no2 has very low oil level below the minimum required gauge required lubricant replacement.
- Defrost cycle can only be done manually (PLC and HMI problem)
- Cracked on the discharge pipe on compressor no1 causing refrigerant leakage.
- TXV 507 on both meat room and vegetable room evaporator and its not in accordance with freon specification of R407C.
- Faulty Solenoid on the Vegetable room evaporator.
- Faulty valve on the meat room evaporator.
- Compressor no1 was meet decommissioned and dismantled.

# FAULTY COMPRESSOR 1 DECOMISSIONED

- Decommission of defective compressor
- Installation of new compressor.
- Replacement of new foundation bolts.
- Installation of compressor lubricant warmer.

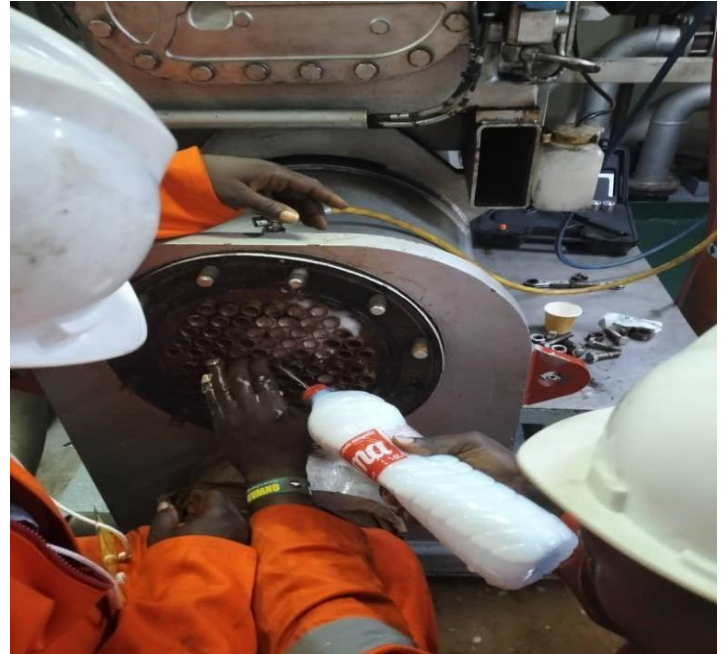
| <b>REPORT BY:</b> MEDAAN ENGINEERING SERVICES LIMITED<br>TEAM | <b>WORK SCOPE:</b> The accommodation A.C plant 1 has leaks on pressure<br>gauge lines. Leakage on 3/8 pressure pipes, leakages on high<br>pressure valves and leakages in the condenser.<br><br>Troubleshooting and repairs of Reefer System Panel and Servicing of all<br>the contactors. Refrigerant leakages, Faulty sensors, and electrical Panel<br>Issues. | |

A.C condenser leakage findings

1. Fabrication of new pressure gauge lines using  $\frac{1}{4}$  size copper pipes.
2. Fixing of leakages on  $\frac{3}{8}$  pressure pipes.
3. Fixing of leakages on condenser tube by construction of brass bullets
4. Changing of gasket and seals around the condenser.
5. Flushing of the condenser using nitrogen gas
6. Replacement of compressor oil and compressor gas (407 gas).
7. We pressure test for Ten (10) hours with the pressure at 45psi and it maintains the pressure.

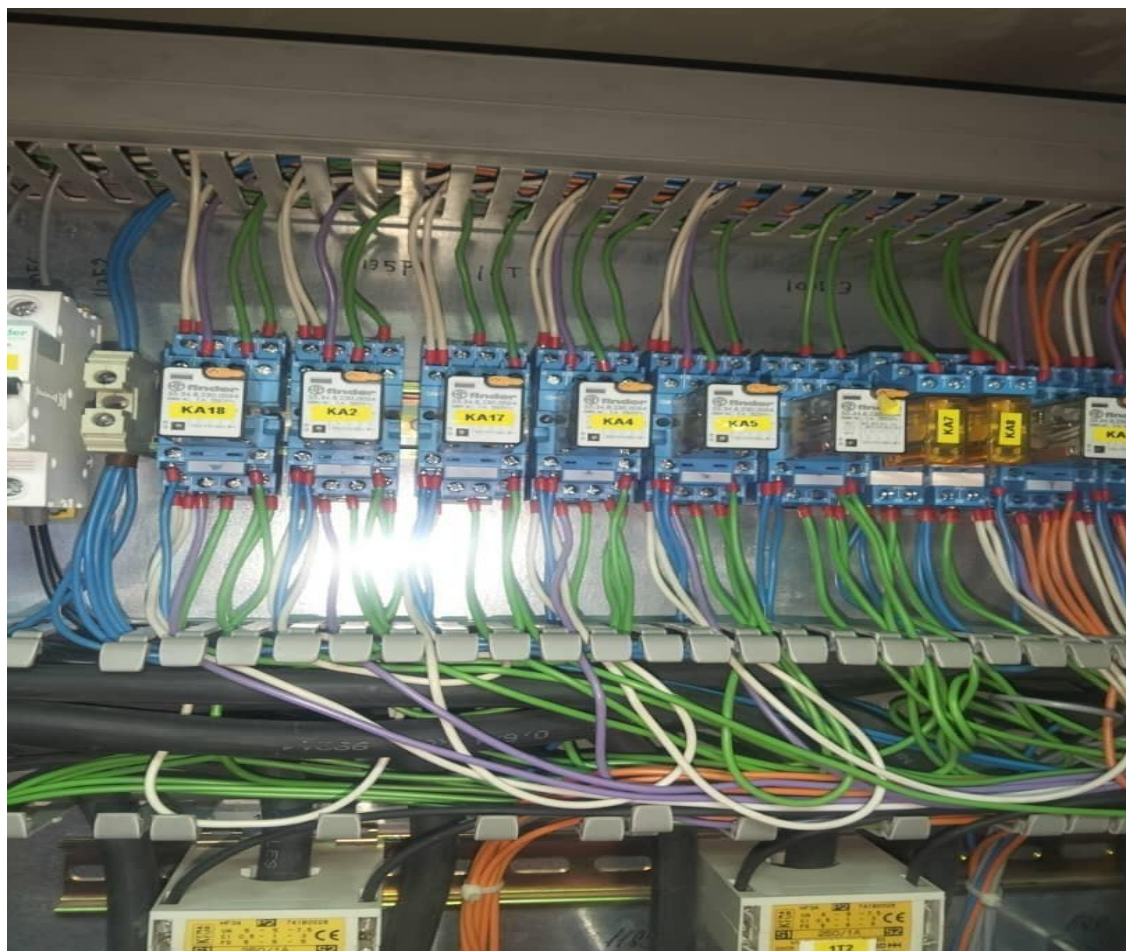
**2.** Extensive Troubleshooting repairs of Reefer System Panel and  
 Servicing all the contactors. Refrigerant leakages, Faulty sensors,  
 and electrical Panel Issues.

Cleaning and Serviced Electrical Wiring Connection And Contactors by Medaan Team
